STUDLEY ROYAL LAKE OUTLET WEIR AND CASCADE,
FOUNTAINS ABBEY & STUDLEY ROYAL,
NORTH YORKSHIRE.

REPORT ON
A PROGRAMME OF ARCHAEOLOGICAL MITIGATION
(LEVEL 1 BUILDING RECORDING AND WATCHING BRIEF)

OSA REPORT NO; OSA24WB20

September 2024

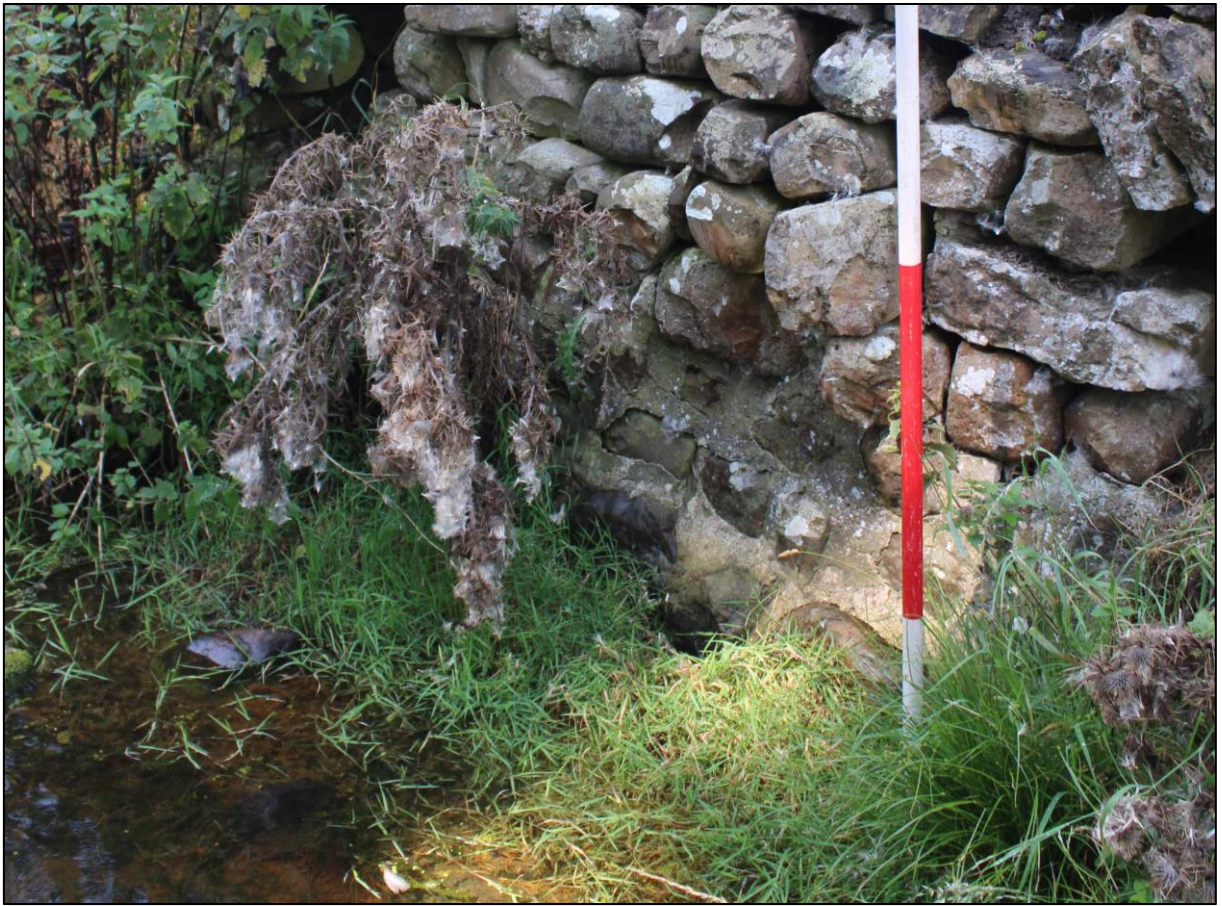
The North wall of the outlet comprises two elements. Immediately downstream from the weir cascade this consists of well-dressed regular coursed ashlar blocks, and gently slopes down from west to east under horizontal coping stones (Plate 3). This section is believed to date from the 1890s refurbishment of the outlet and was not to be impacted upon by the proposed repair works. The second element comprises the drystone section immediately to the east (downstream) of the higher ashlar build, which is to be subject of the current repair work (Plate 4). At the time of the initial pre-commencement recording the main elevation of this drystone section was partially obscured by vegetation (Plates 5 and 6). The drystone element consisted of a combination of water worn cobbles / small boulders, together with roughly squared quarried limestone blocks and thick flags. No tool marks were observed on any of the masonry. Whilst no bonding material was evident between the majority of the individual stones the lower courses (approximately 0.50m height above the river water level) included hard grey cement render, presumably as a recent attempt to protect the wall from river erosion (Plate 7).

Plate 7. North wall, detail of cement render.

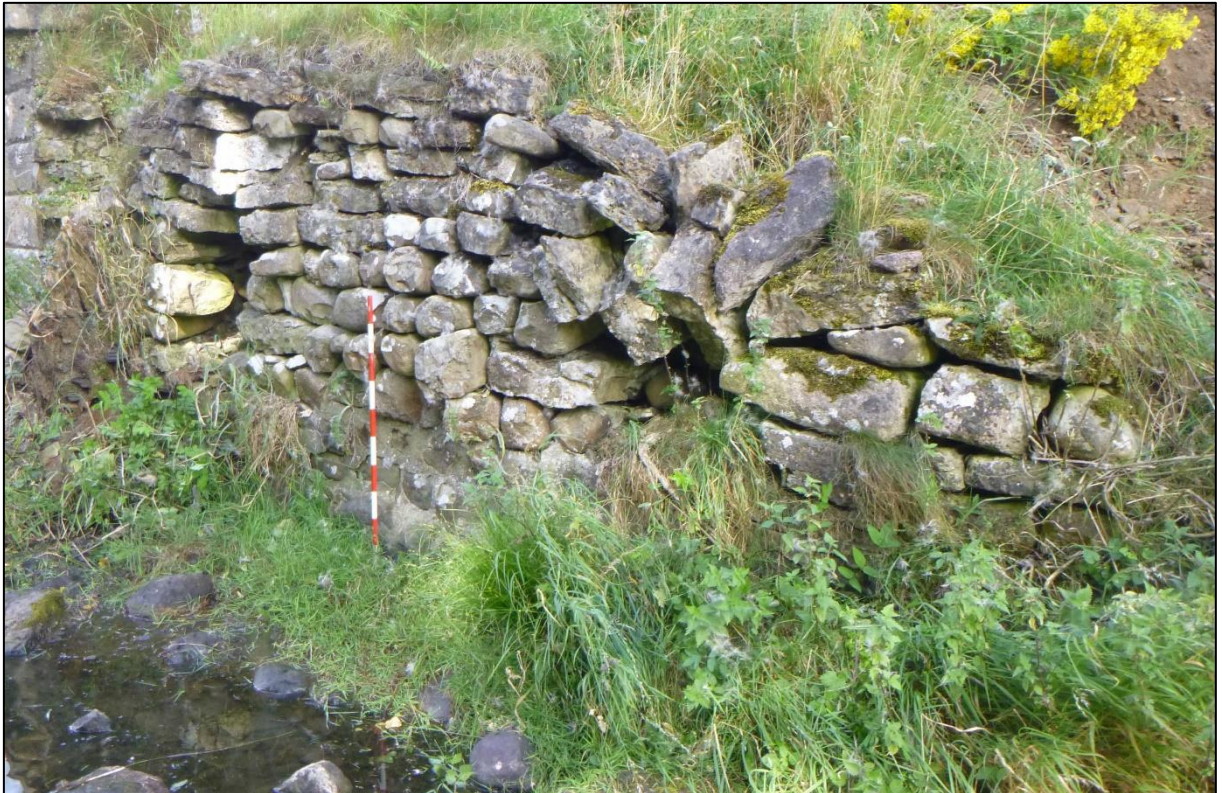
The first stage of the repair works involved careful removal of some of the vegetation by hand, providing an opportunity to further inspect and record the wall prior to any physical intervention (Plate 8). Whilst this revealed slightly more of the wall, it did not add any significant information regarding its construction.

Plate 8. North wall, oblique view after some vegetation clearance.

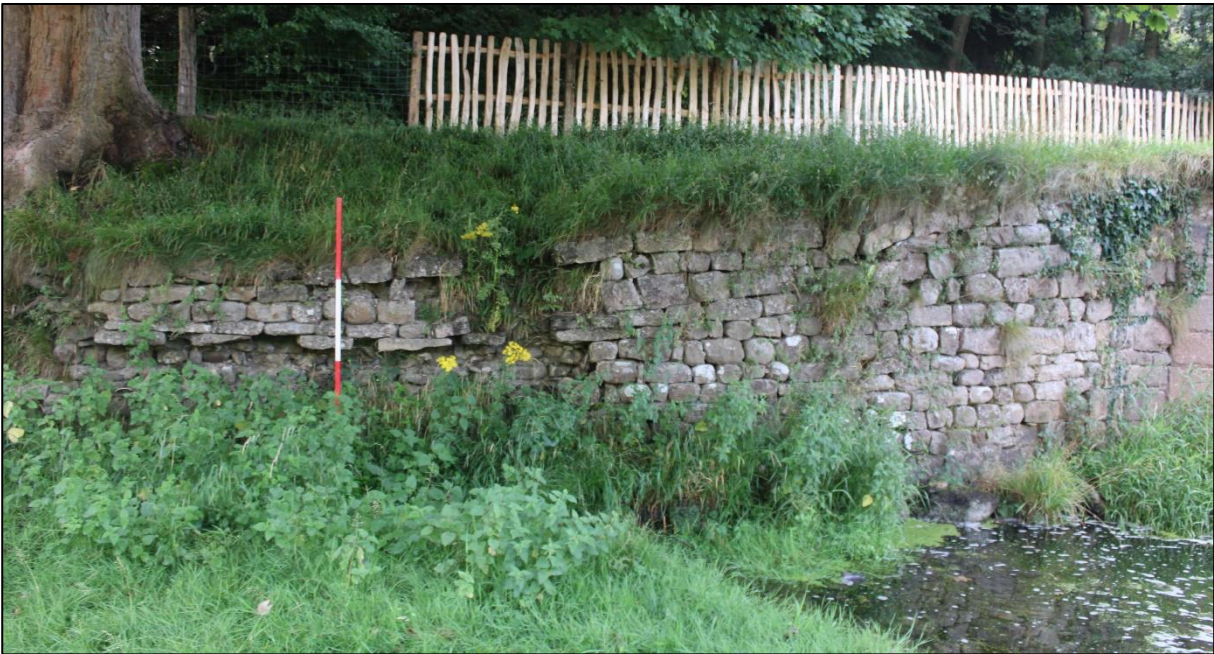
wall was the best preserved, and highest, continuing the gradual slope downstream, from the adjacent ashlar portion (Plate 13). Further to the east the south wall was less well preserved and lower, with individual blocks having been displaced (Plate 14). In places the lower part of the wall had lost substantial portions of the facing stones (Plate 15). The most significant area of damage was located immediately below a substantial (sycamore) tree, where roots had caused the complete loss of a section of the wall, in excess of 1m across (Plate 16).

Plate 13. South wall, west section.

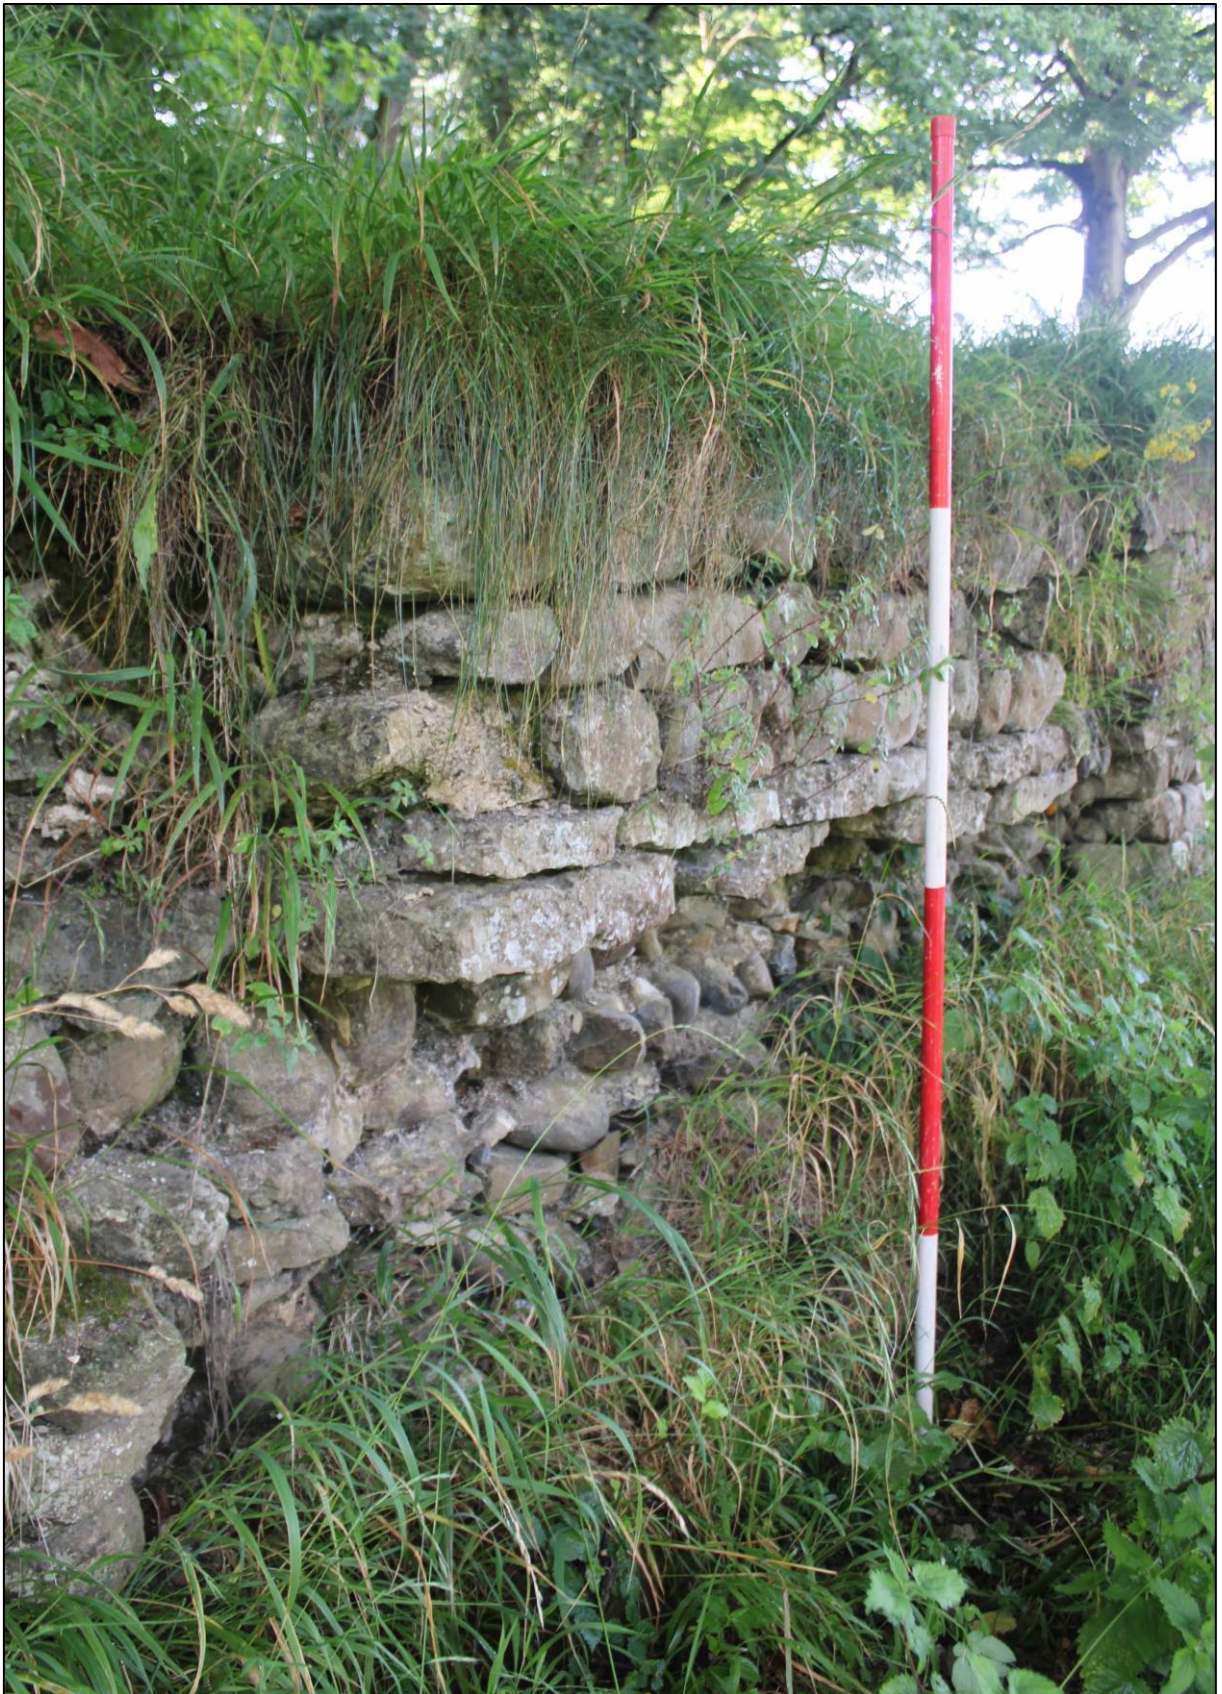
Plate 15. South wall, detail of damage / erosion.

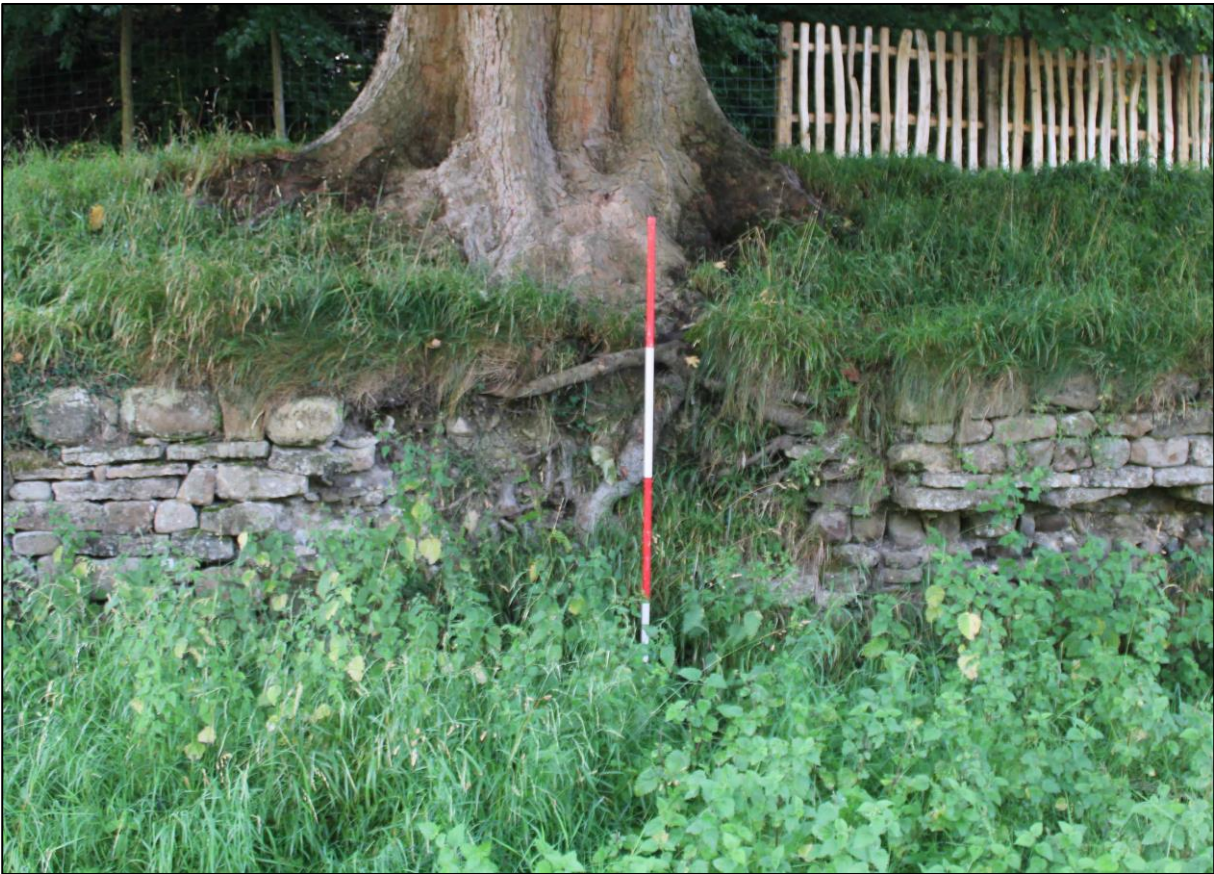
Plate 16. .South wall, detail of tree root damage.

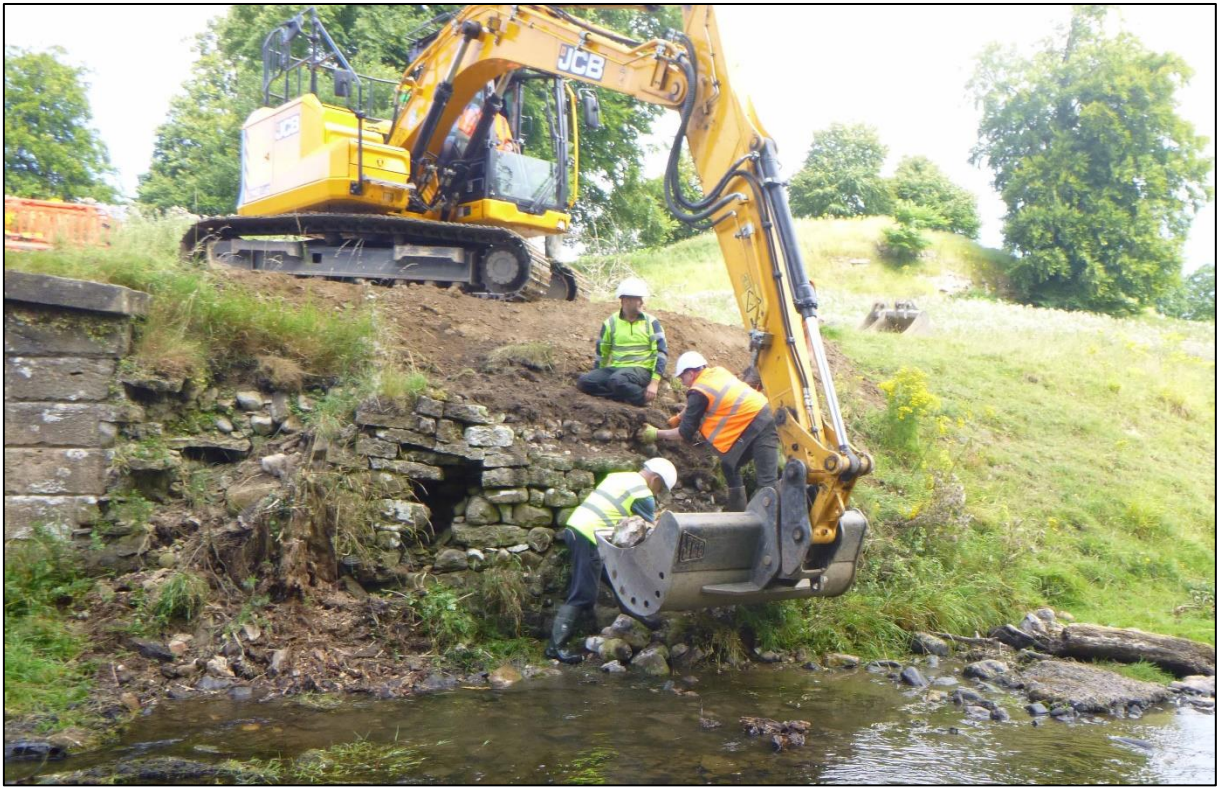
The level working area was then utilised to provide machine access to assist with the careful dismantling of the wall (Plate 18). The reclaimed stone was carefully placed to allow the attending archaeologist to inspect it for any reused masonry or tool marks (Plate 19). None of the stonework included any toolmarks and none of the fragments included any features that suggested reuse from elsewhere on the estate. This was notable in its contrast with elements of the canal walls located closer to the Abbey ruins where numerous fragments of medieval masonry were present (see for example JB Archaeology Ltd, 2016 and Newman, 2017).

Plate 18. Removal of North wall.

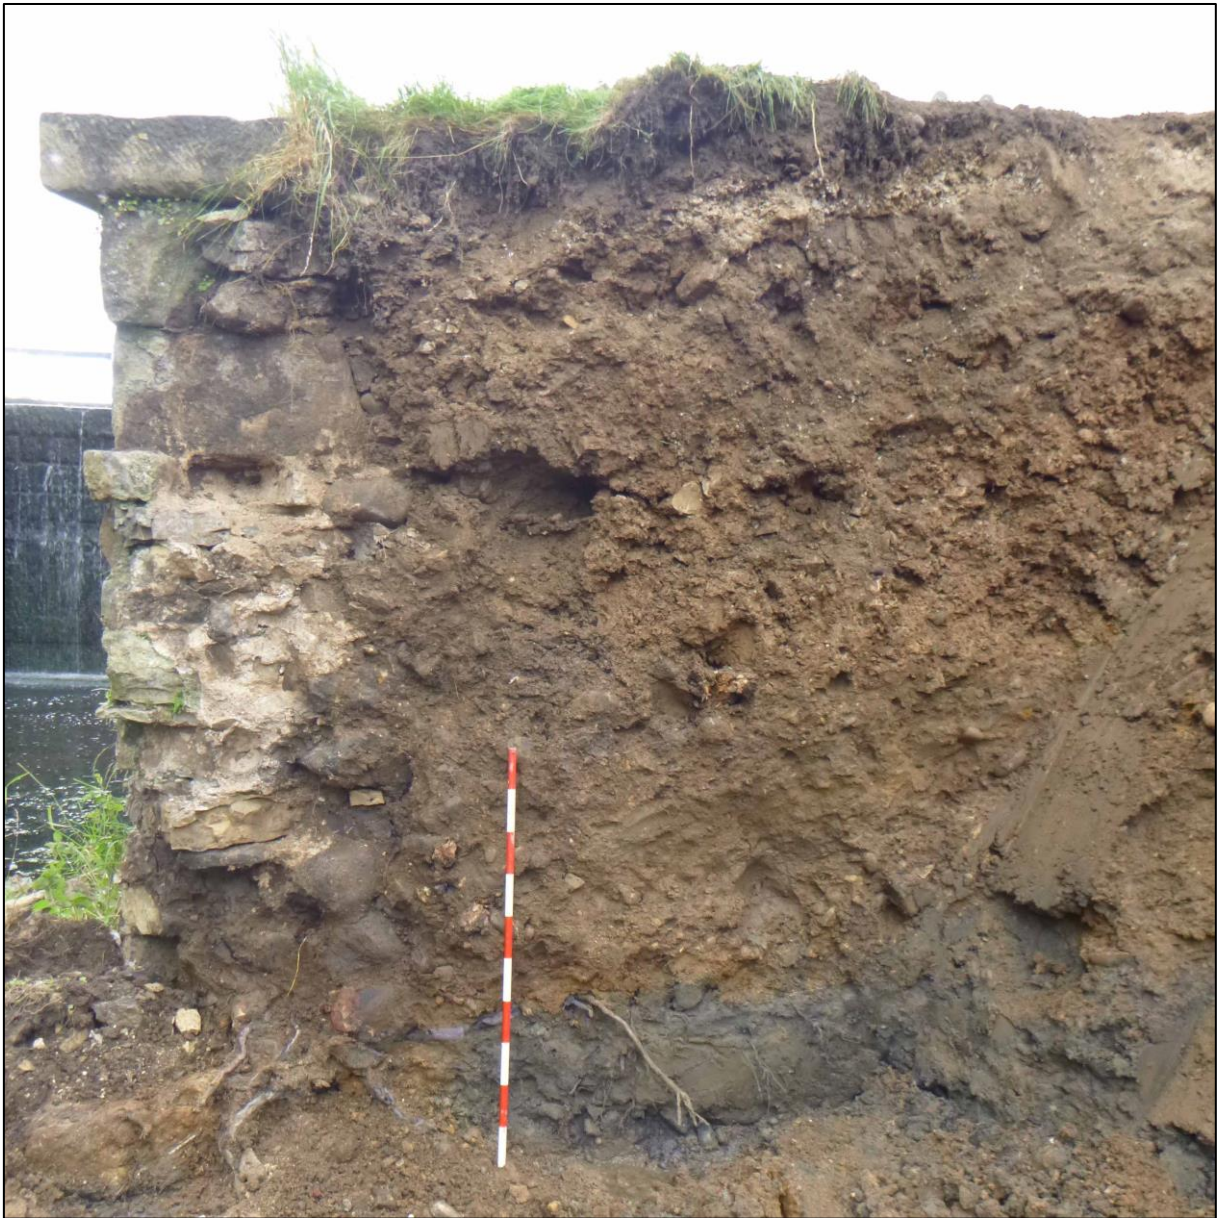
Following the removal of the drystone wall, the bank behind was mechanically excavated to provide sufficient space for the insertion of the new gabion baskets and to rebuild the external face of the wall. At its base this excavation extended to a maximum of 2m back from the original wall face, with the northern limit of excavation being sloped for safety reasons so at the top of the bank the excavation was around 3m back from the original face of the wall (Plate 20). The exposed vertical sections were rapidly cleaned and recorded to enable an understanding of the archaeological sequence impacted upon by the excavation (Plates 21 and 22 and Figure 5).

Plate 21. East facing section.

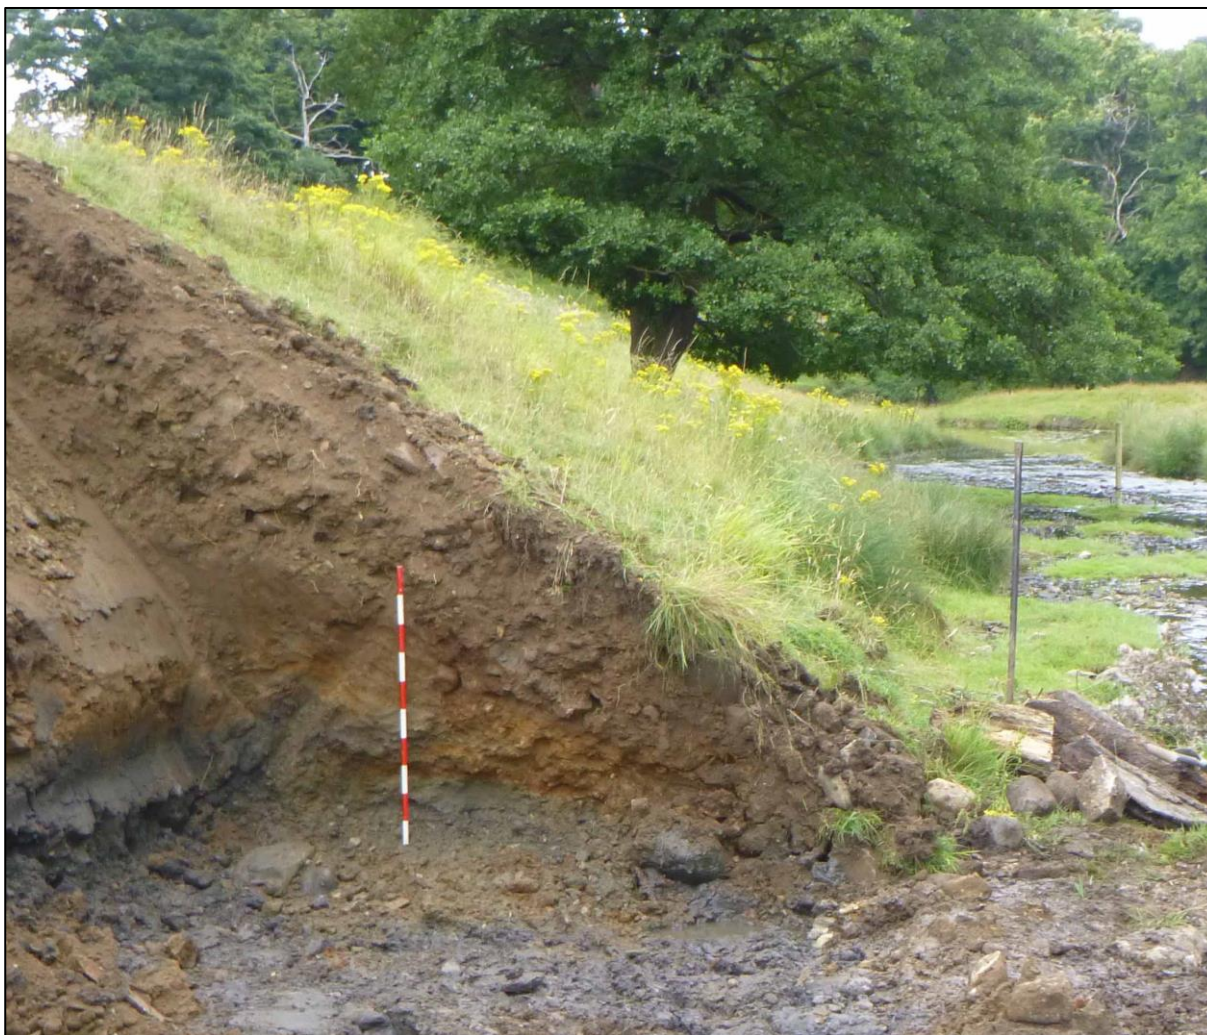
Plate 22. West facing section.

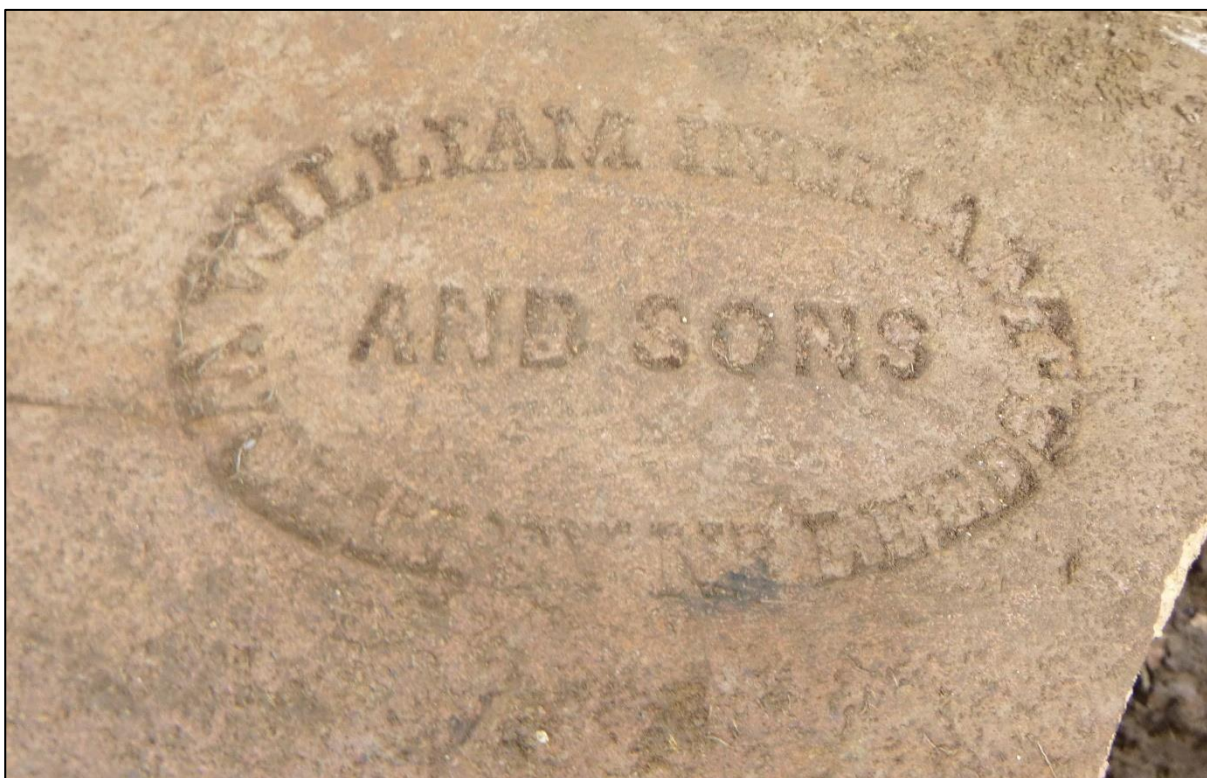
(from bank towards the river). Within the western edge of excavation this was likely to represent a construction cut [106] for the ashlar outlet wall (109), which extended to the west. Deposit (105) butted up against the rear (north) side of the wall confirming that it comprised construction backfill. Further to the east the interface was less well defined as a cut, but may have continued as a construction cut for the drystone element of the wall (102), which had been removed for repair. Two 19th century glazed drains (103) were observed within deposit (105). Fragments of one of these included a makers stamp “William Ingham & Sons. Wortley Nr Leeds” (Plate 23). This company had been founded in 1825 by William Ingham, trading from 1834 as “and Sons”, and produced multiple fireclay items until 1889 when they formed part of the Leeds Fireclay Co.

Plate 23. Stamped drainpipe.

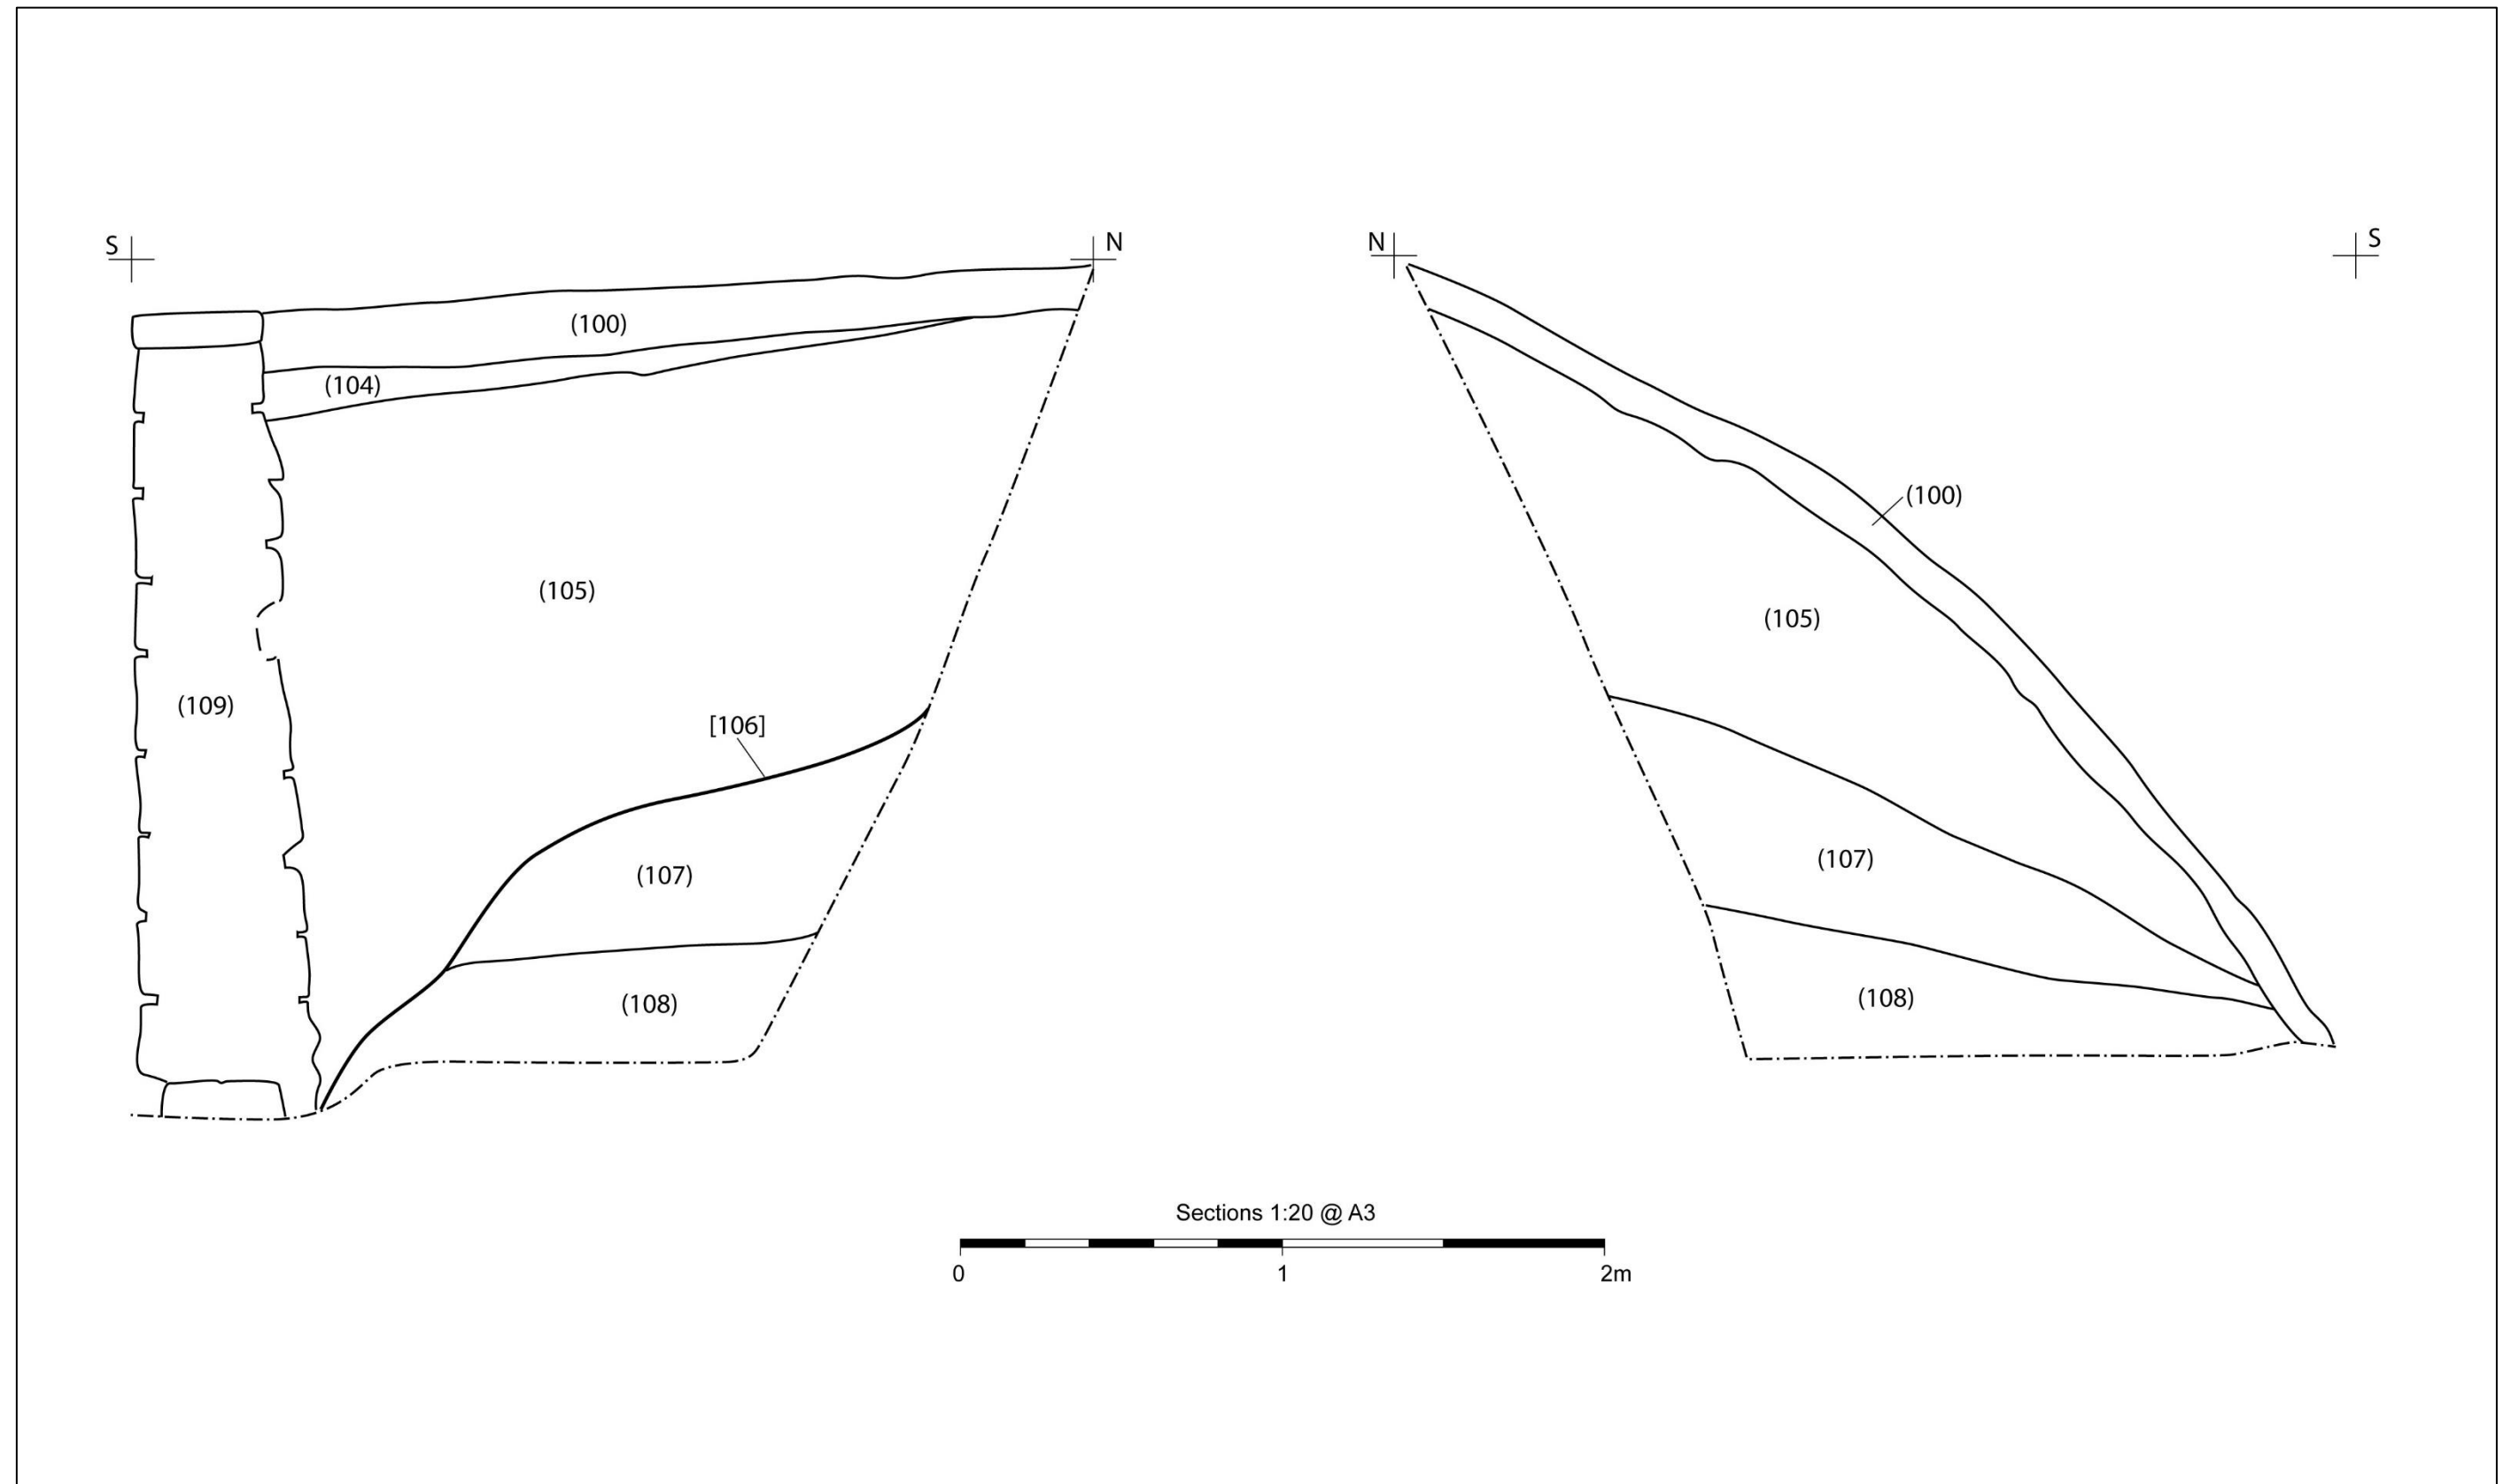
Figure 5. East (left) and West (right) facing sections.

Throughout the excavated area the earliest recorded deposit comprised a soft mid grey sandy clay silt (108) containing frequent pebbles. This deposit was a maximum of 0.40m thick within the excavated area but clearly extended to the east, north and west, and below the basal limit of excavation. This was sealed by a loose, pale yellow brown coarse sand and gravel (107). These two deposits both appear to represent natural river deposits, pre-dating the construction of the formal walled channel. Although no dating evidence was collected or observed they are therefore likely to pre-date the early 18th century when works to this area of the estate were commenced for John Aislabie.

The coarse sand and gravel deposit (107) was sealed in both the east and west sections of the excavation area by a thick mid yellow brown silty clay with pebbles and cobbles (105). The interface between deposits (107) and (105) sloped significantly down from north to south

The top of backfill deposit (105) extended up, almost to the modern ground surface. Within the western end of the trench it was overlain by a thin deposit of loose cream coloured lime mortar (104). Patches of similar mortar were observed on the eastern end of the ashlar wall (109), which appear to represent attempts to bond this wall with the earlier drystone element (102) to the east. No similar mortar was observed within the main body drystone wall (102) during its dismantling. The thin mortar deposit (104) is likely to be a construction deposit associated with the late 19th century building of the ashlar wall (109).
