OUTLET DAM AT STUDLEY ROYAL WATER GARDEN.

REPORT ON AN ARCHAEOLOGICAL EVALUATION

OSA REPORT No: OSA17EV32

December 2017

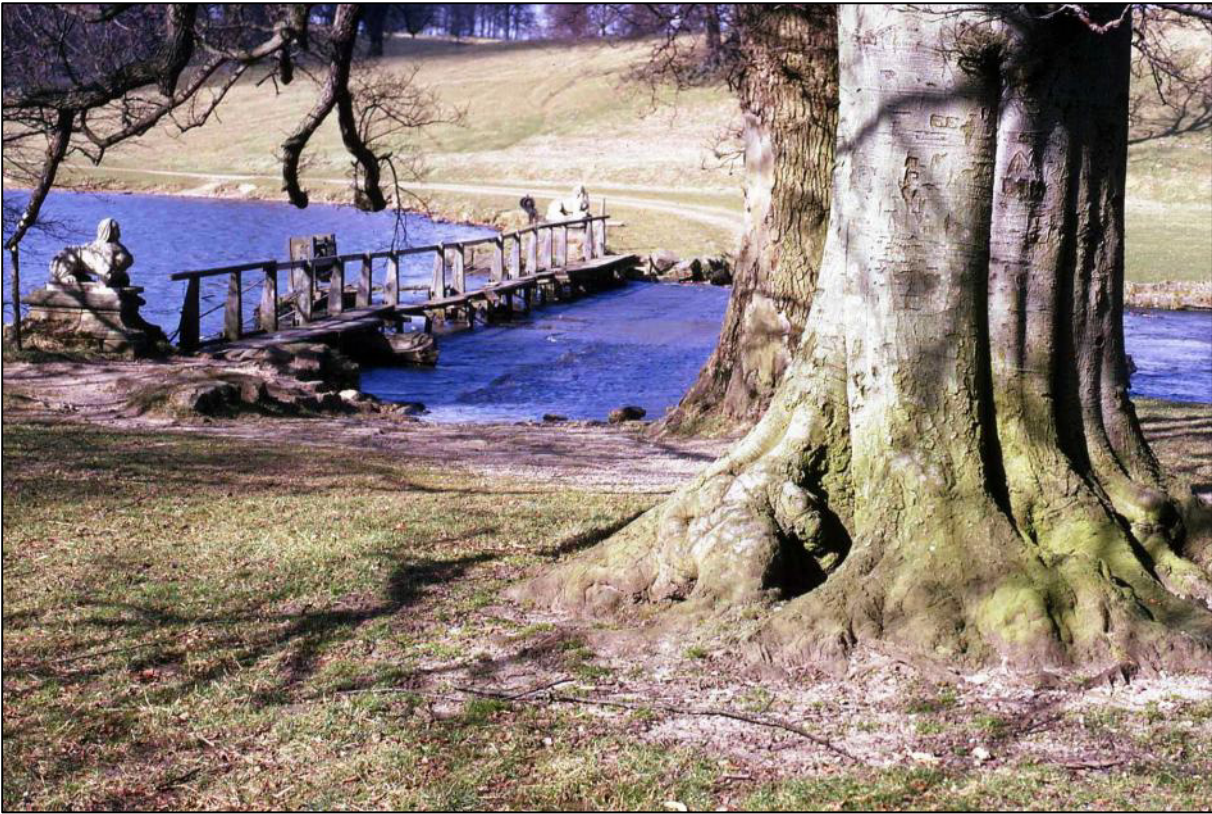
Shallow excavation of the existing concrete dam surface revealed variable stonework (104/105/106/107/108) forming the historic surface of the dam (**Plates 4-7**). Two parallel narrow, shallow channels within the stonework and forming part of the upper construction of the historic surface extended across the width of the dam. These channels measured a maximum of 0.30 metre wide and 0.20 metre deep, approximately 0.30 metre apart, and contained the remains of long sub-structure support beams (henceforth labelled as "timber beams") (101/102/103) (**Plates 8-19**). These timber beams were interpreted as the base of a former footbridge (**Plate 3**).

The date and relationship between the timbers is unclear but two phases appear to be visible. The dam is recorded to have been constructed in the early 18th century; a footbridge matching the surviving remains is depicted in a mid-18th century painting by Balthazar Nebot (**Front Cover**) and was also photographed in 1967 (**Plate 3**) as part of property photo survey.

Plate 3. The dam and former footbridge as seen in 1967 Property Photo Survey. ©National Trust.

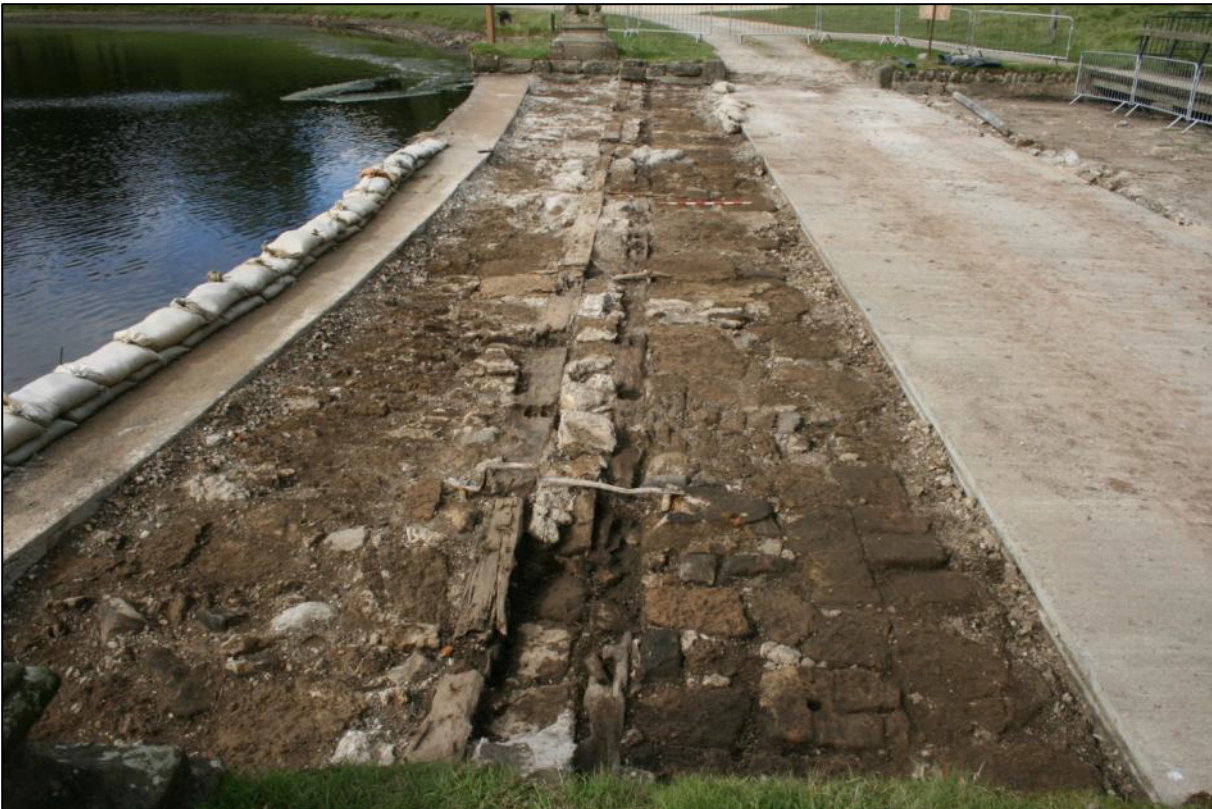
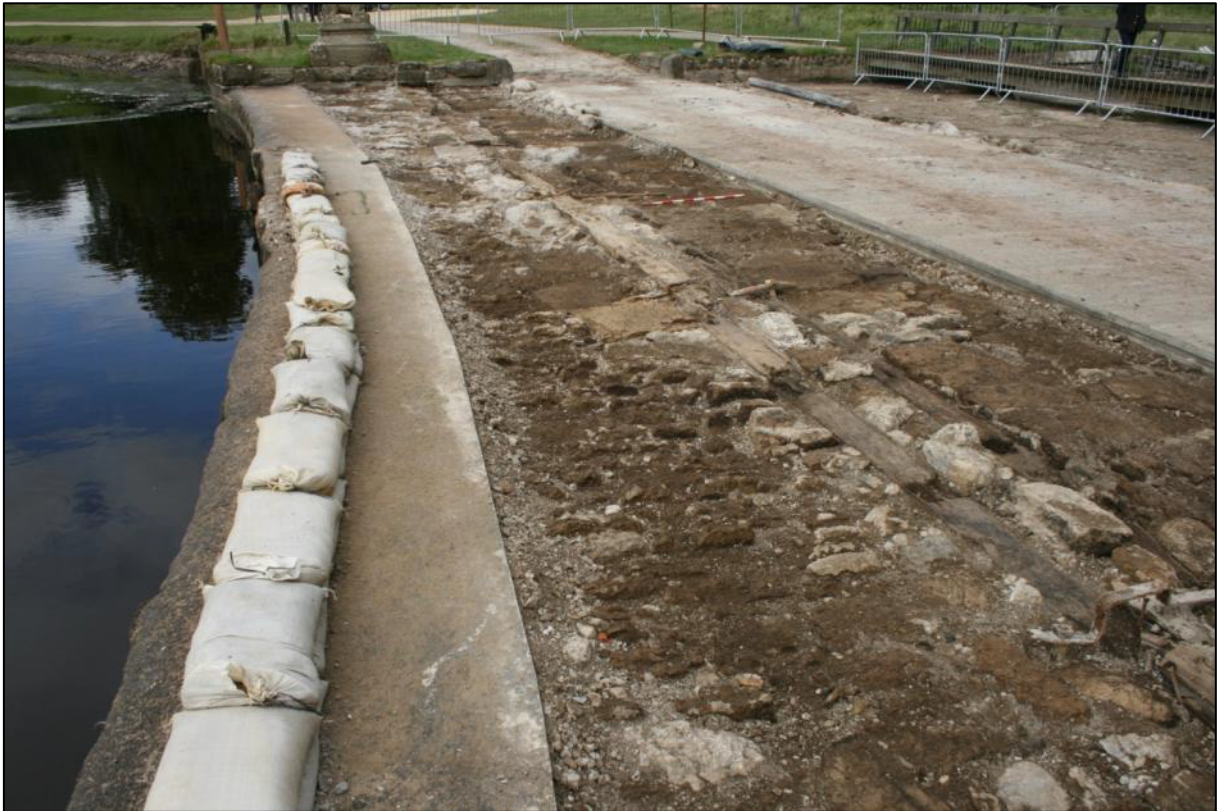
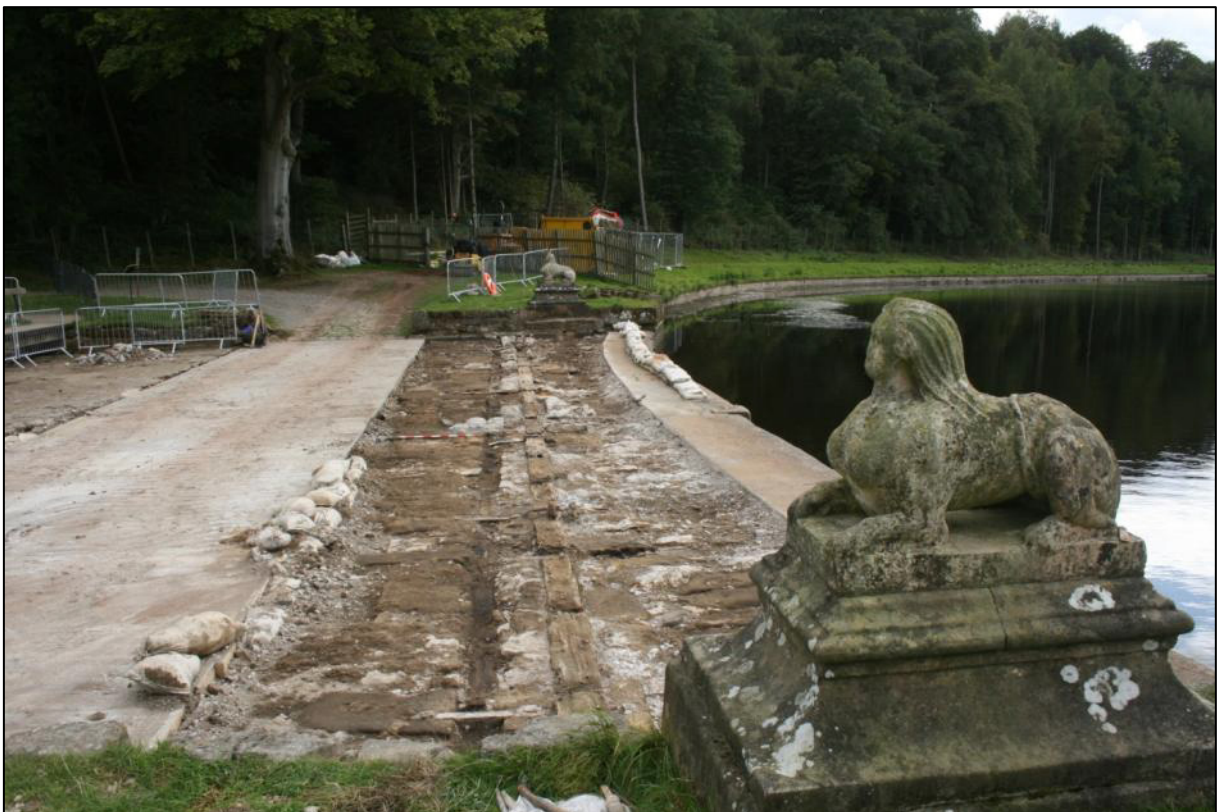
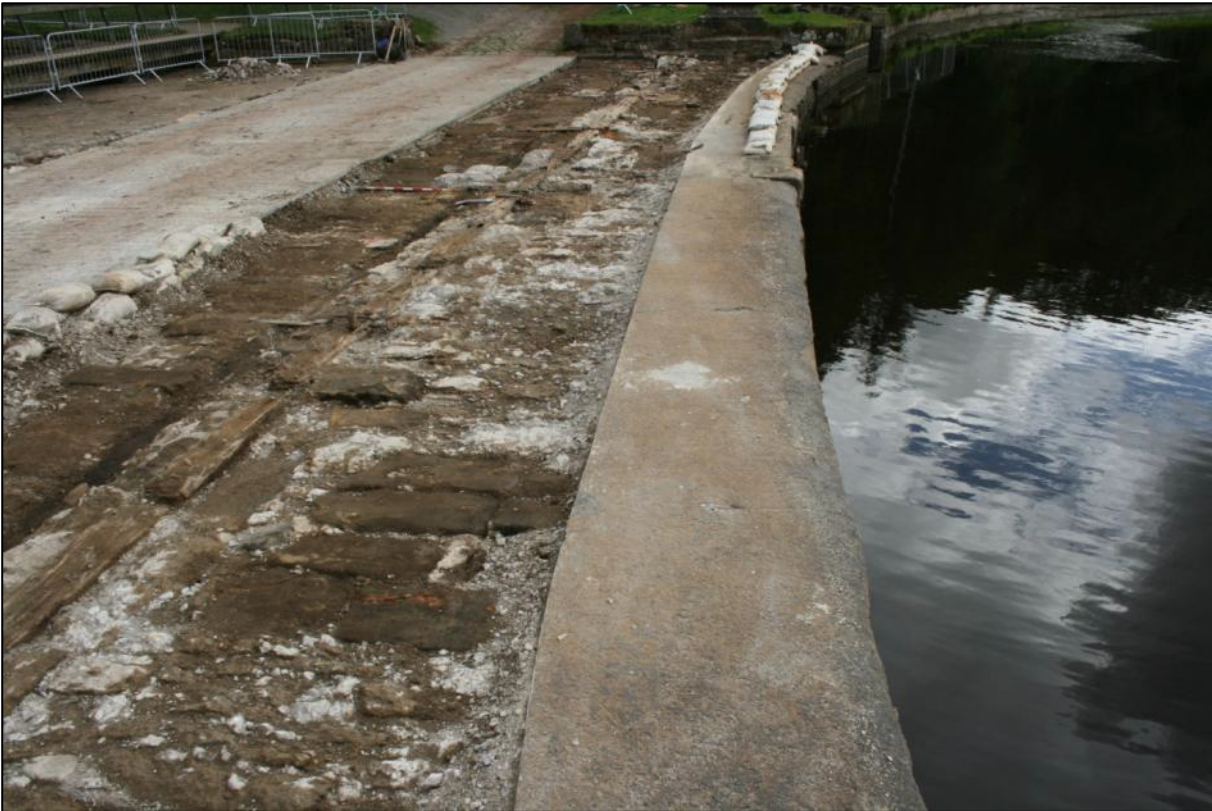
Plate 4. Post-removal of 20th century concrete, pre-recording, looking north-northwest.

Plate 5. Post-removal of 20th century concrete, pre-recording, looking north.

Plate 6. Post-removal of 20th century concrete, pre-recording, looking south.

Plate 7. Post-removal of 20th century concrete, pre-recording, looking southeast.

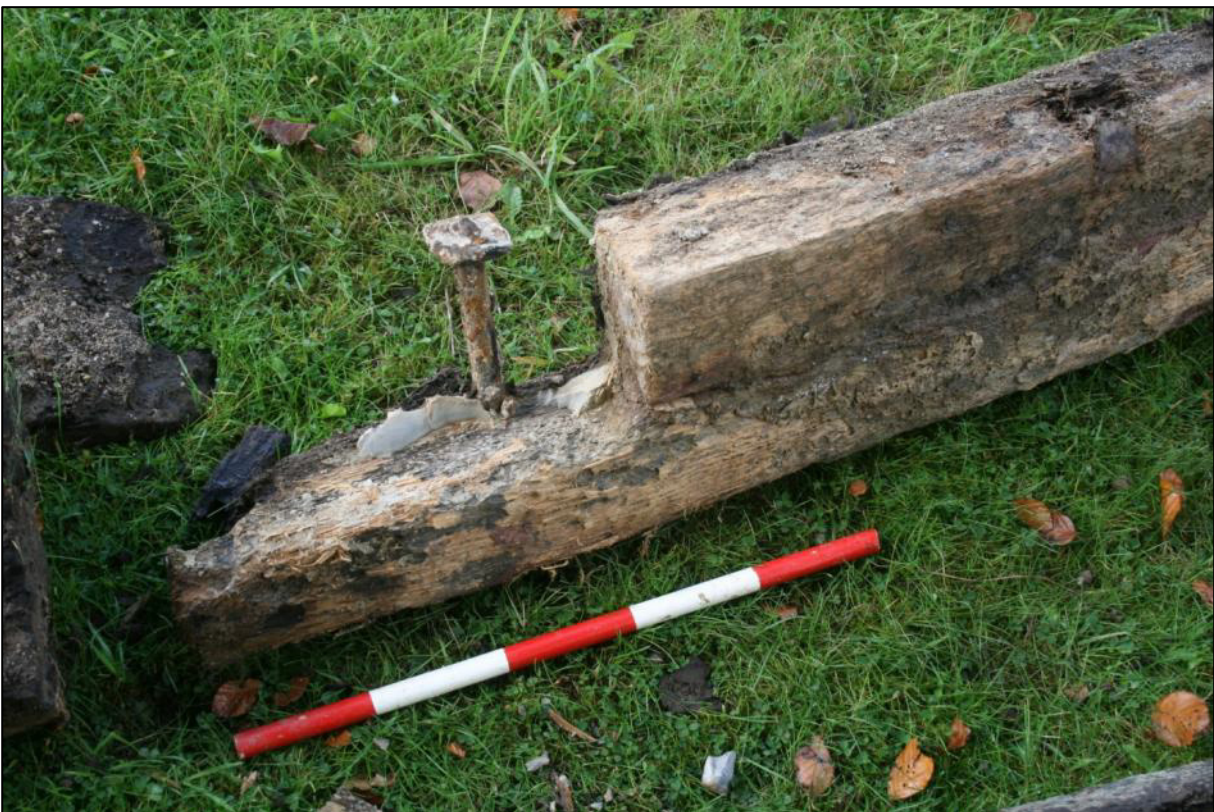
The timber beams within the western channel comprised of two layers: (101) was some 0.05 metre thick; and (102) was around 0.12 metre thick. The lower level (102), likely a hardwood, consisted of several long lengths of timbers connected using a lap joint with iron nails (**Plate 20**). Two pairs of vertical pins (111) were visible following the removal of the timber beams (**Plate 21**), which were mortared to the base of this channel presumably to hold the timber beams in place. The upper run (101) also consisted of long lengths of timber connected using both splayed and lap joints (**Plate 22**), and were affixed to the lower timber run (102) by several smaller iron nails. Several mortises were visible in both levels of timber beaming (see previous Plates), appearing to have supported the tenons of vertical timbers (**Plate 23**). The differences in the wood, dimensions and joints of the two layers of timber beaming may suggest they represent two phases of construction, or structural repair.

Plate 20. Lap joint and affixing nail for (102).

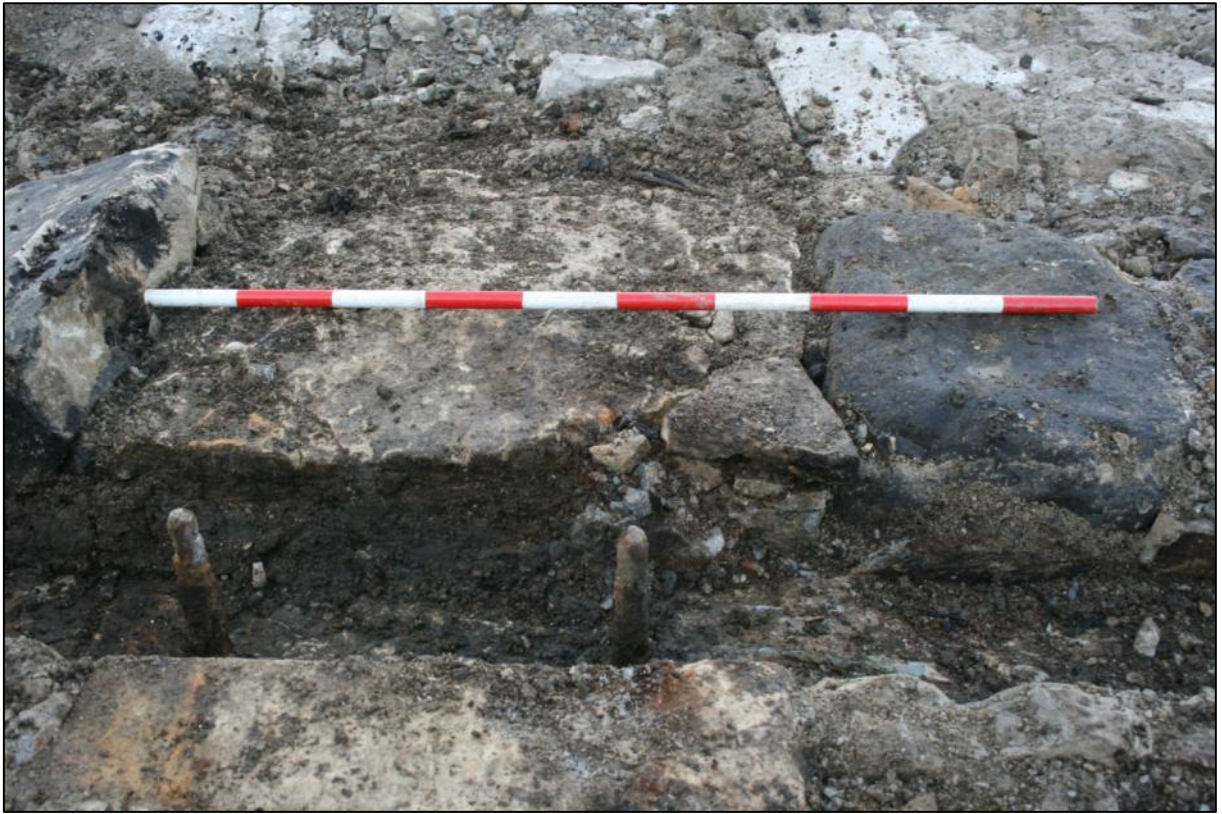
Plate 21. Upright pins (111), 13 metres along baseline.

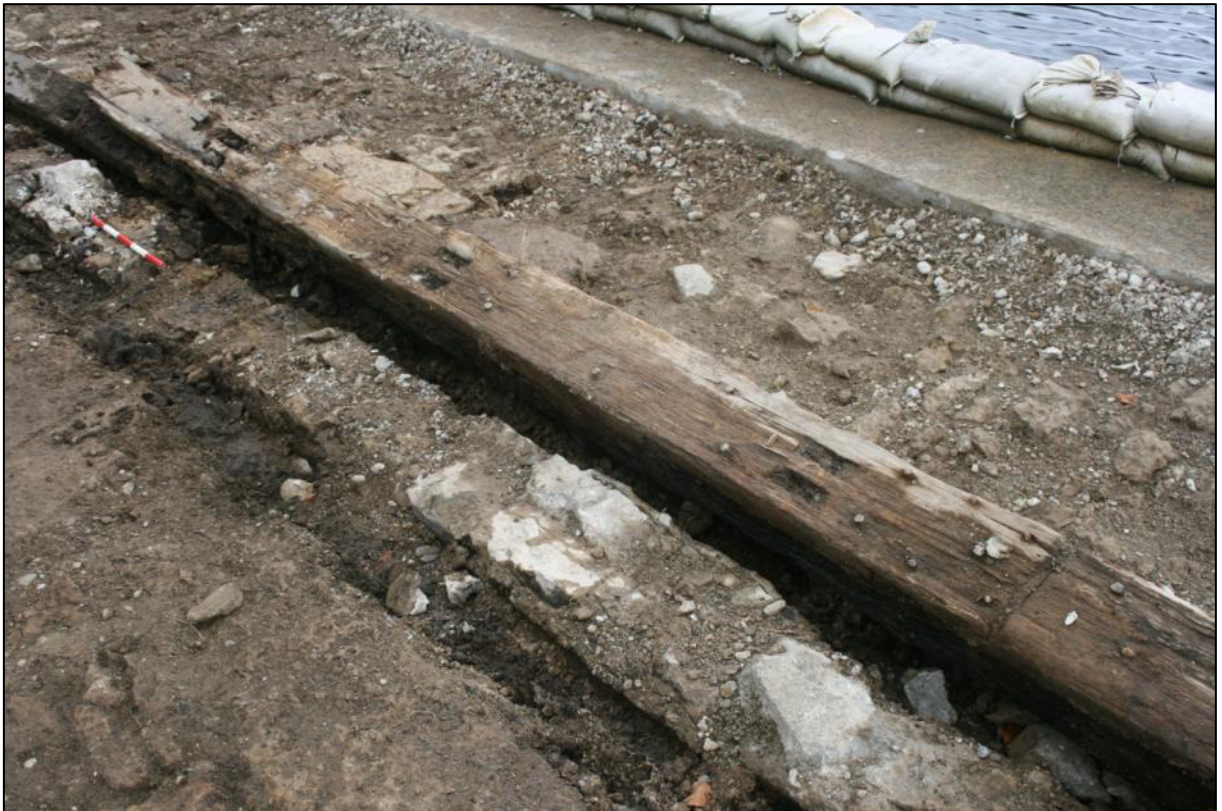
Plate 22. Lap joint foreground-right and splayed joint background-left, for upper timbers (101), around 7 metres along baseline.

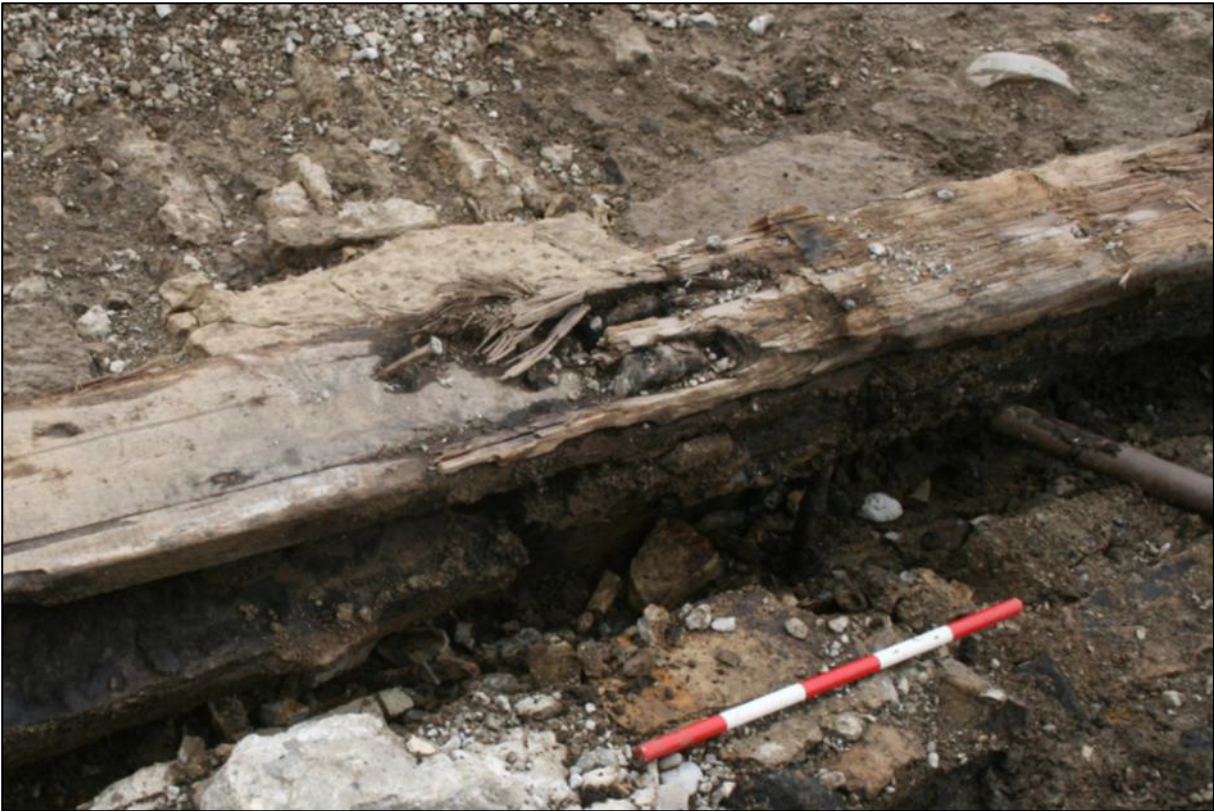
Plate 23. Mortises still retaining inserted tenons, 5-6 metres along baseline.

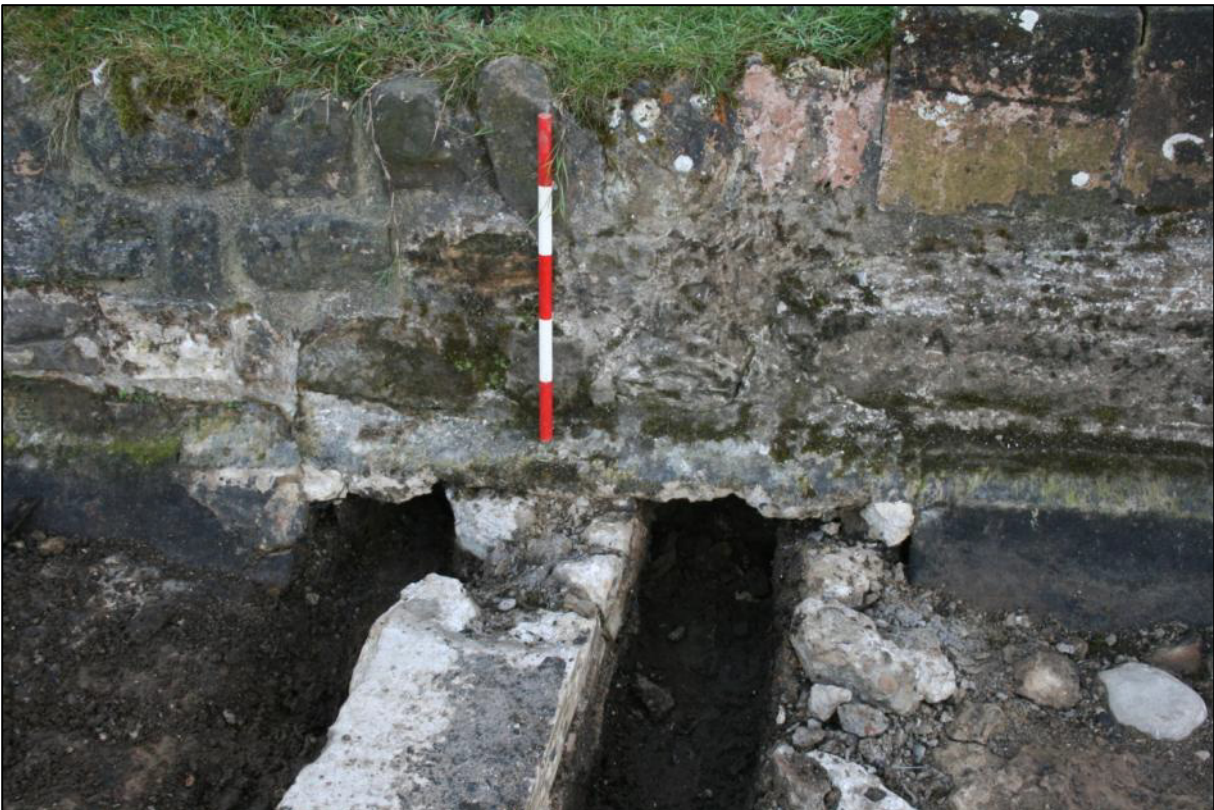
The two parallel channels continued beyond and below the existing southern wall of the dam by approximately 0.40 metre (**Plate 24**) and the northern wall by 0.15 metre (**Plate 25**). Sealed brickwork (112) was visible at the northern end of the channels (**Plate 25**).

Plate 24. Channels running beneath southern dam wall, 0 metres along baseline.

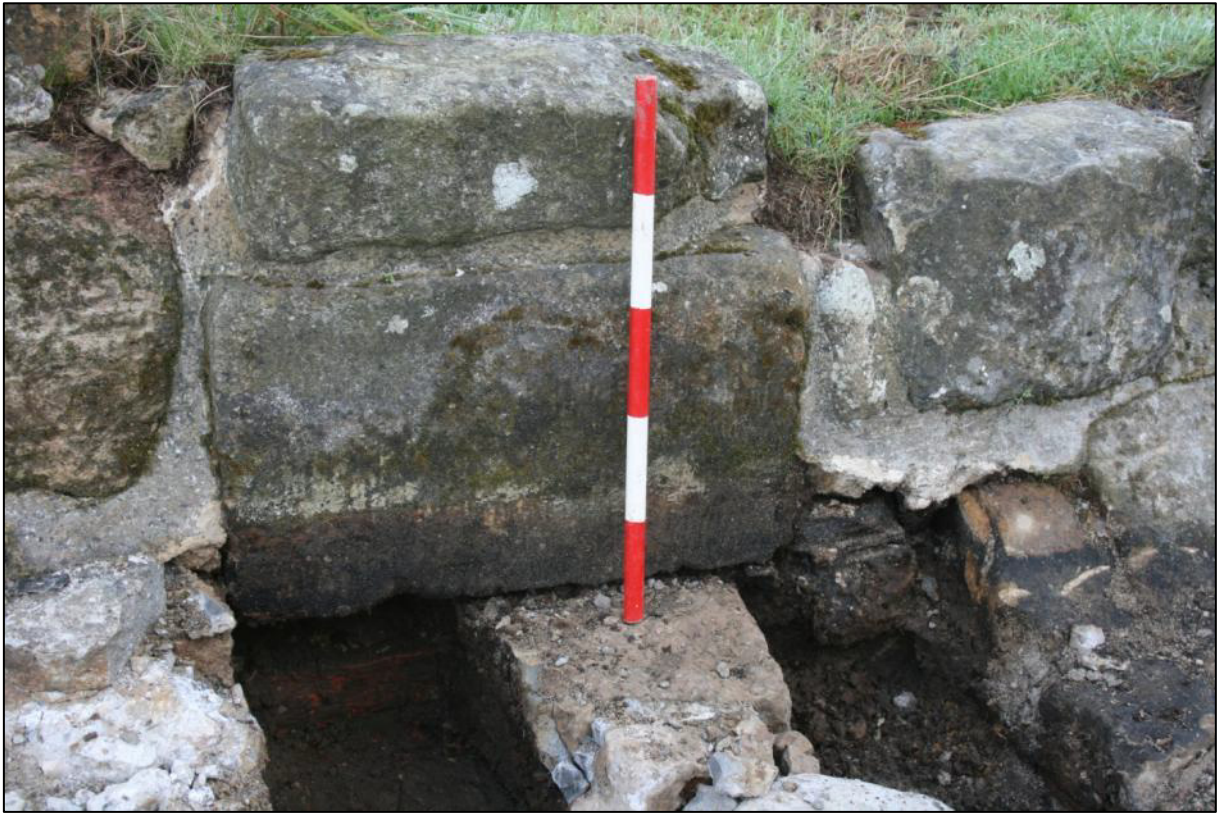
Plate 25. Channels running beneath northern dam wall, showing brickwork (112), 21 metres along baseline.

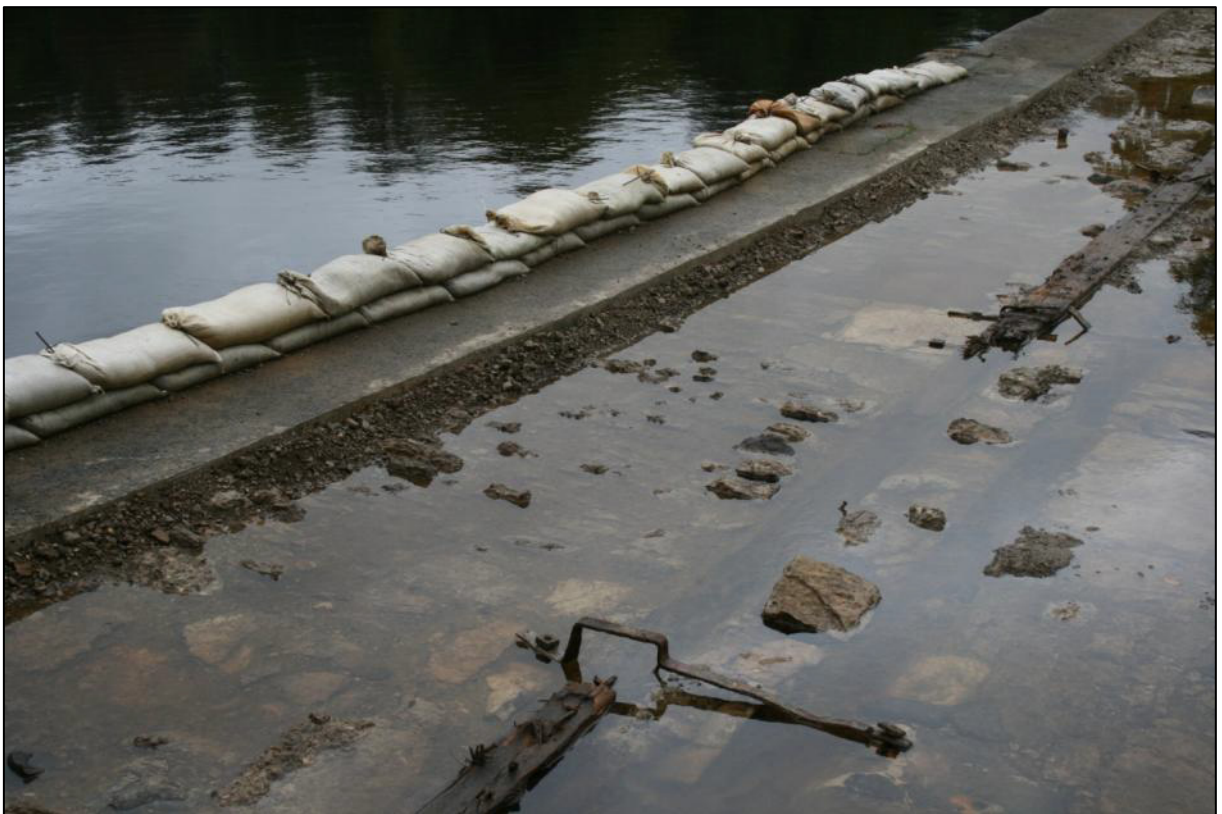
Plate 26. Groundwater flooding accentuating shaped metal straps, looking northwest.

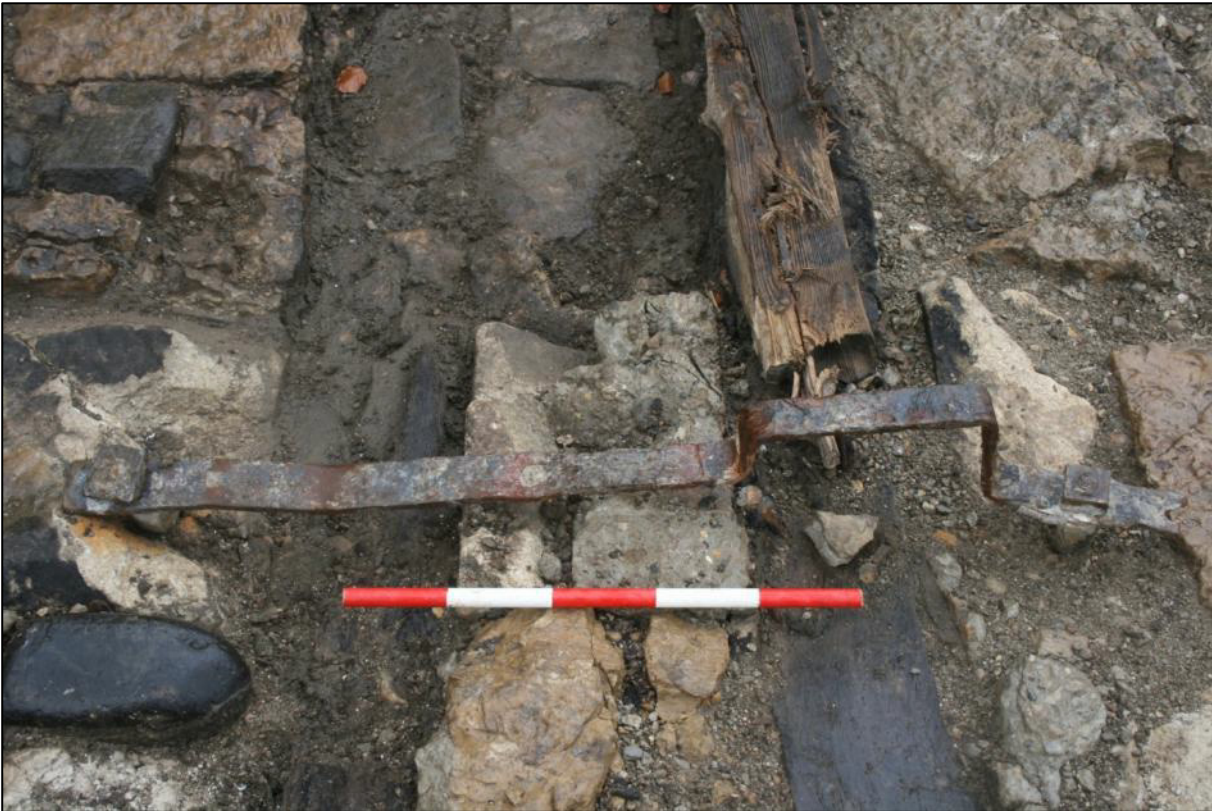
Plate 27. Detail of metal straps, showing the flat form over the eastern run, looking south.

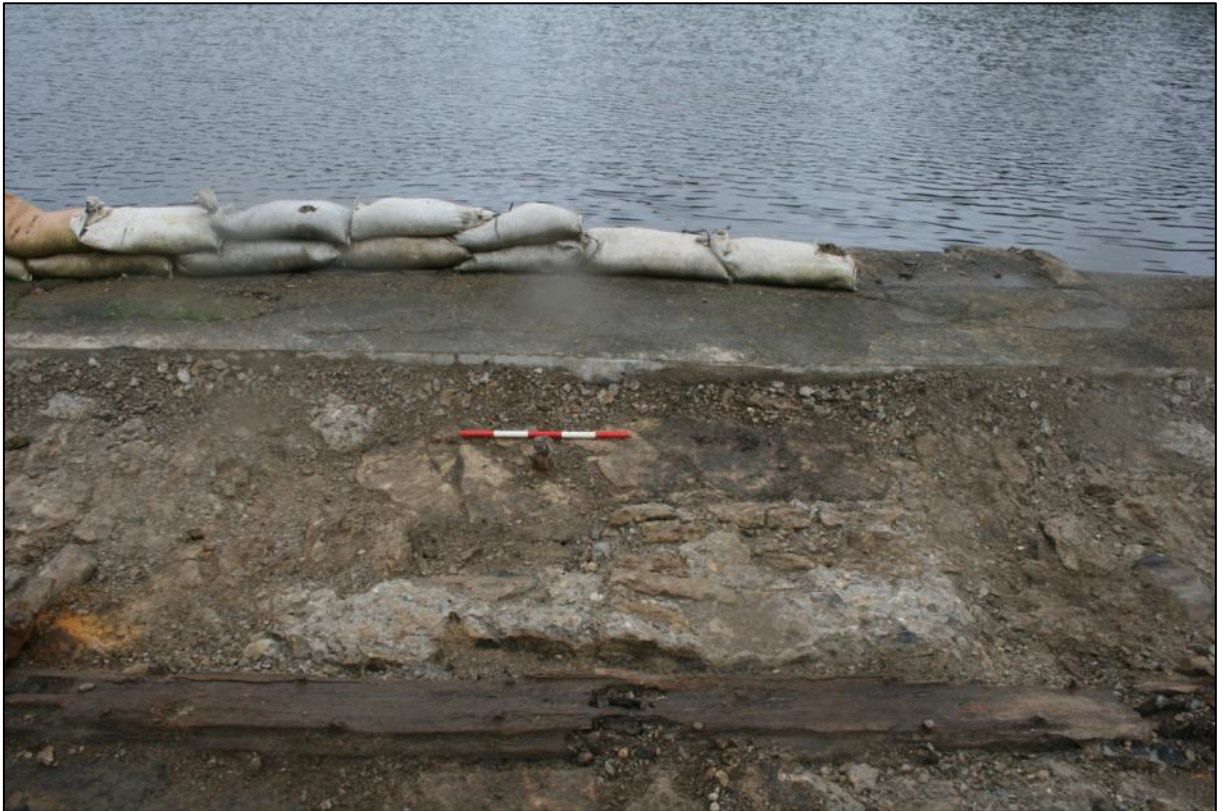
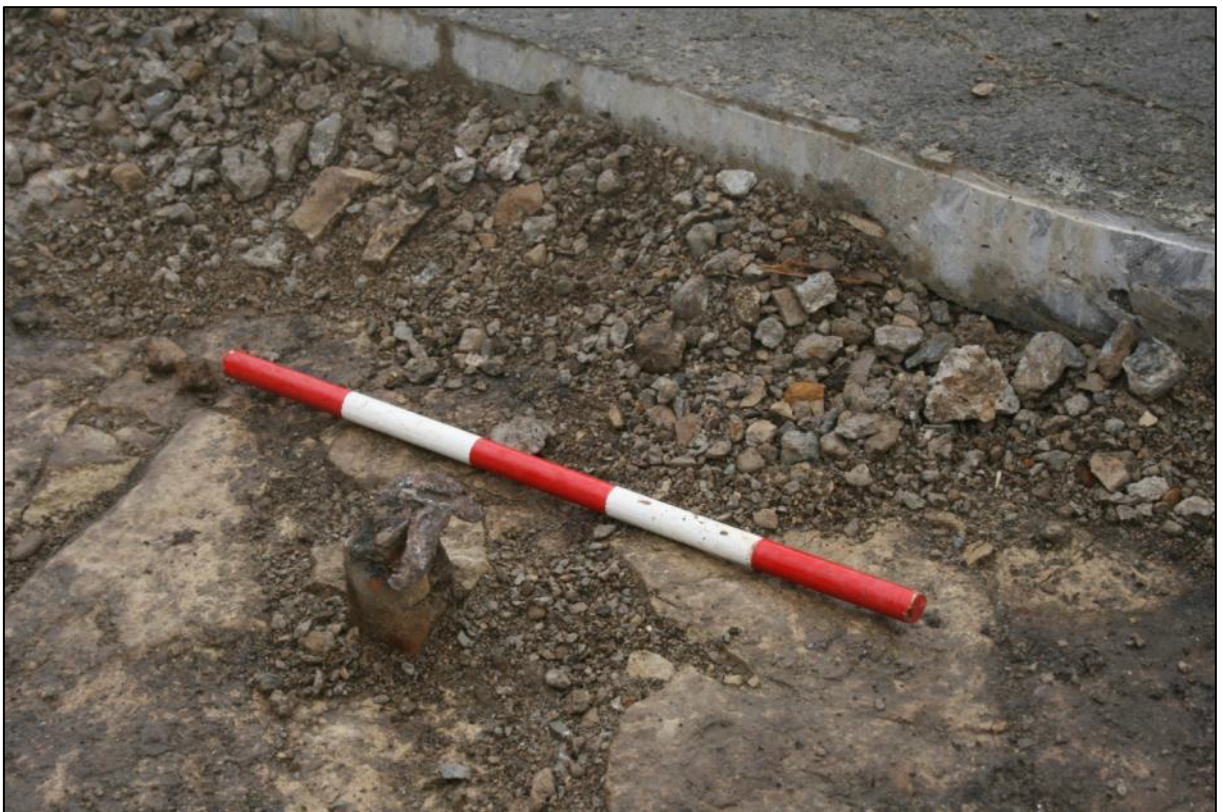
Metalwork (109) associated with the timber construction also survived. This largely comprised of the remains of iron straps which appeared to span both channels and was leaded and mortared to the stonework (see previous Plates). The former shape of the strapping was preserved in some parts that showed that the strapping lay flat across the eastern run of timber beams, yet formed raised over multiple layers for the western run (**Plates 26-27**). Small isolated remnants of former connections to the stonework and timber beams were also recorded (**Plate 28**), including vertical pins (111) below beam (102). An isolated small fragment of metalwork (110) was revealed bonded to the stonework towards the west edge of the dam (**Plates 29-30**), and may relate to the former mechanism of the central sluice gate.

Plate 29. Placement of metalwork (110), around 10 metres along baseline, looking west.

Plate 30. Detail of metalwork (110).

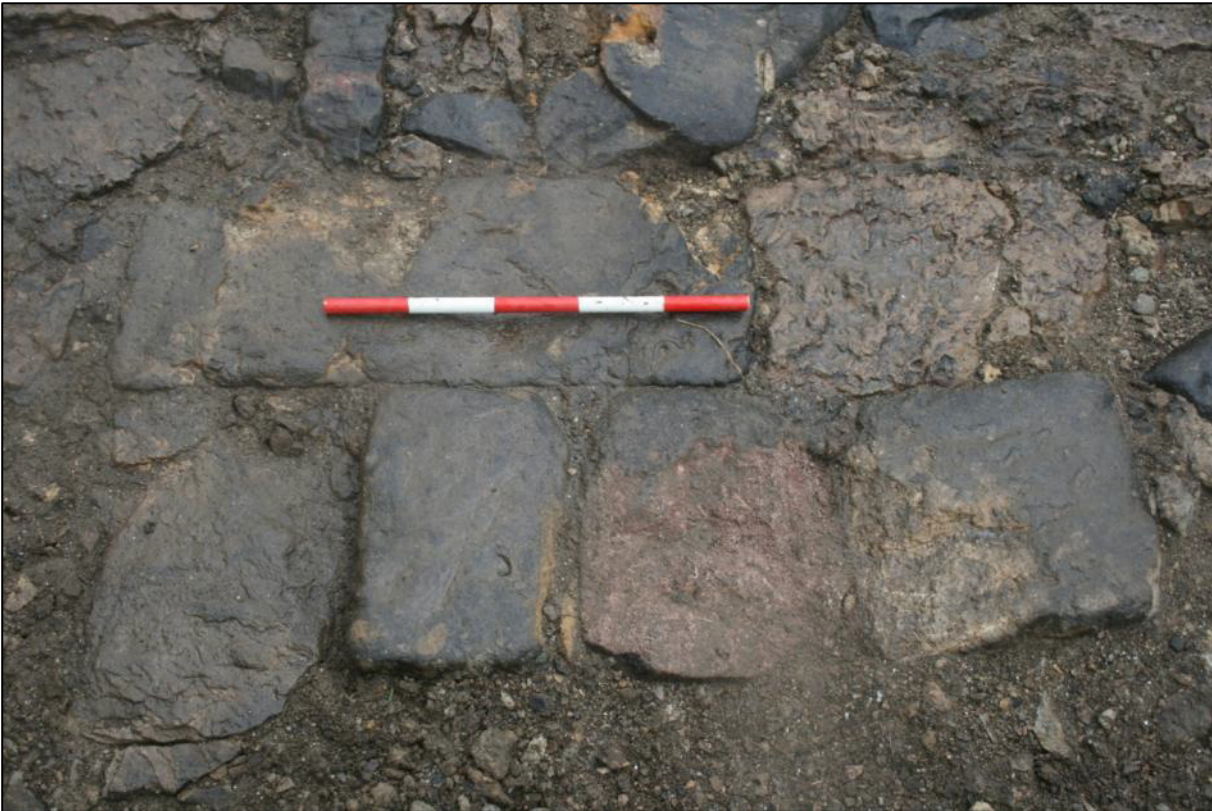
Stonework presented itself in a variety of forms. These included large, locally sourced Millstone Grit blocks (104) typically flanking the timbers (**Plate 31**), discreet areas of cobblestone (105) and limestone (106), reclaimed masonry (107) (**Plate 32**), and swathes of pitched stone blocks acting as a broad base (**Plate 33**).

Plate 31. Sample of Millstone Grit blocks (104).

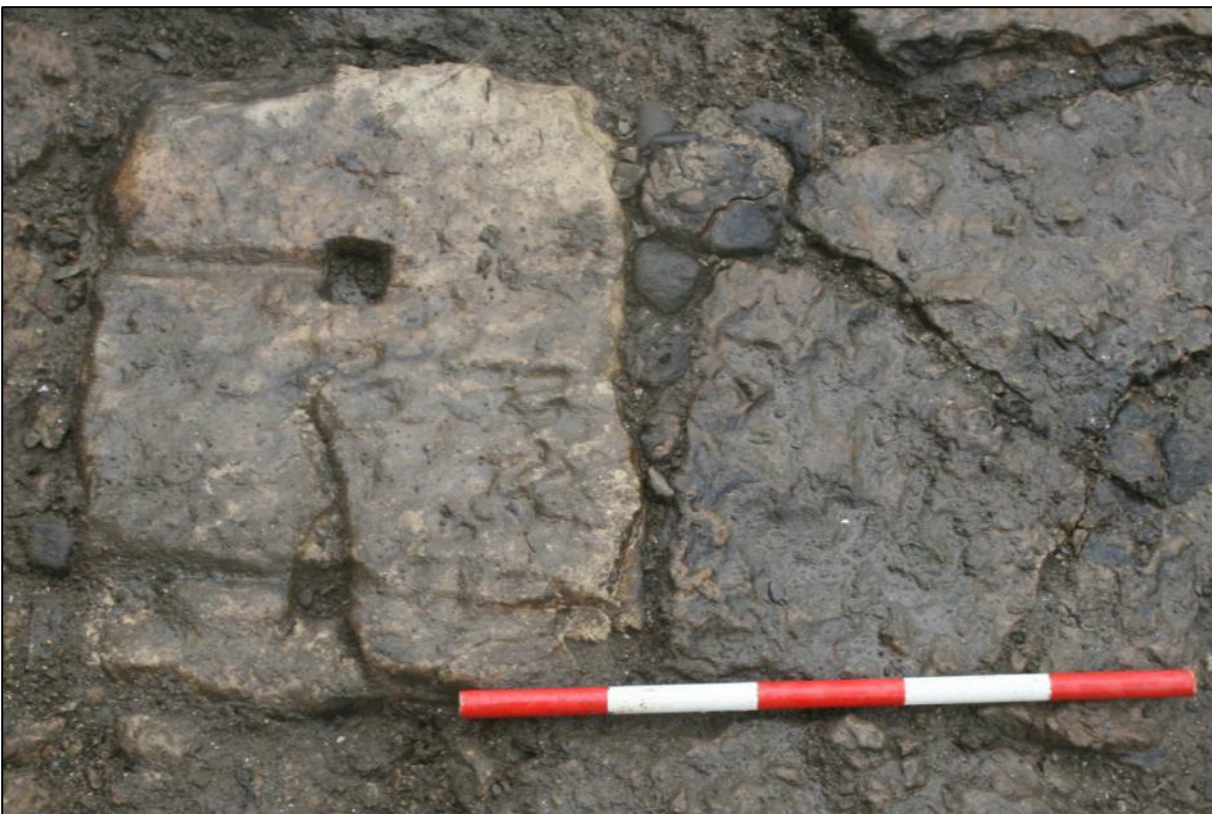
Plate 32. Detail of reclaimed masonry (107), 1-2 metres along baseline, looking west.

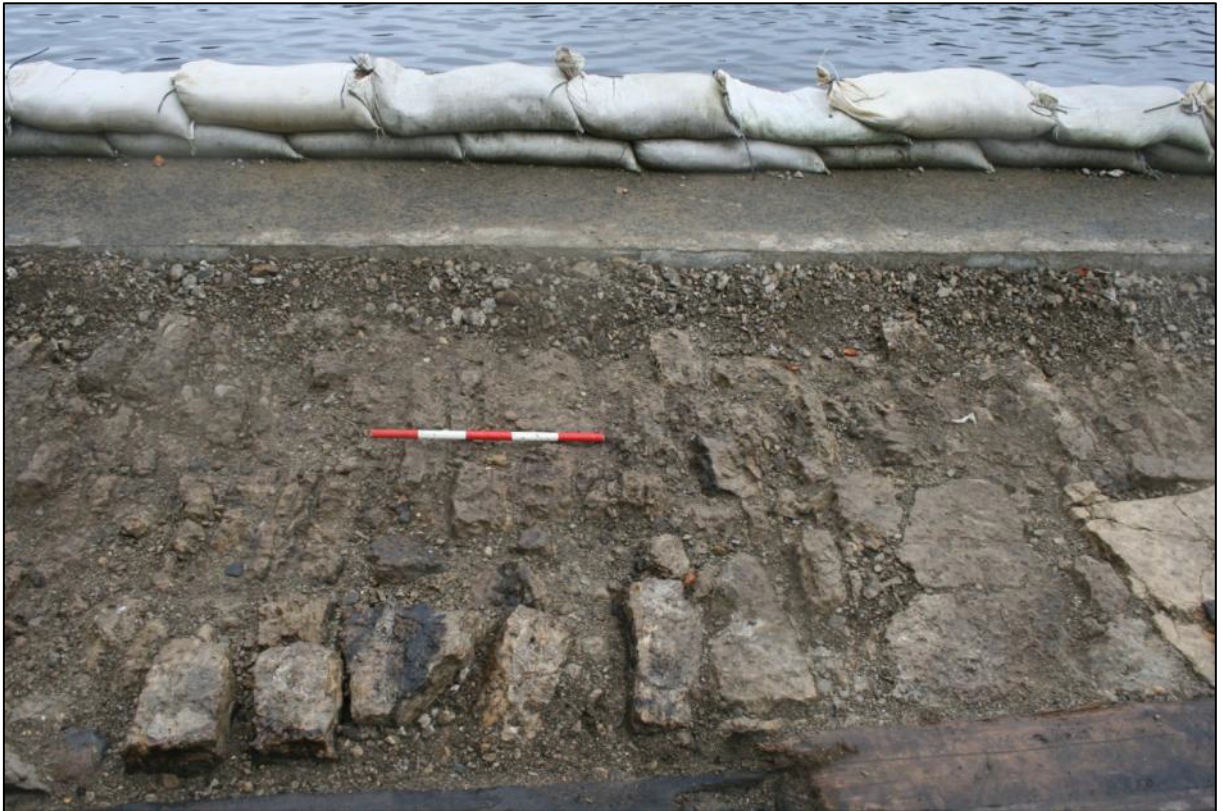
Plate 33. Sample of pitched stonework (108), looking west.
