STUDLEY ROYAL LAKE OUTLET WEIR AND CASCADE,
FOUNTAINS ABBEY & STUDLEY ROYAL,
NORTH YORKSHIRE.

REPORT ON
A PROGRAMME OF ARCHAEOLOGICAL MITIGATION
(LEVEL 1 BUILDING RECORDING AND WATCHING BRIEF)

OSA REPORT NO; OSA24WB20

September 2024

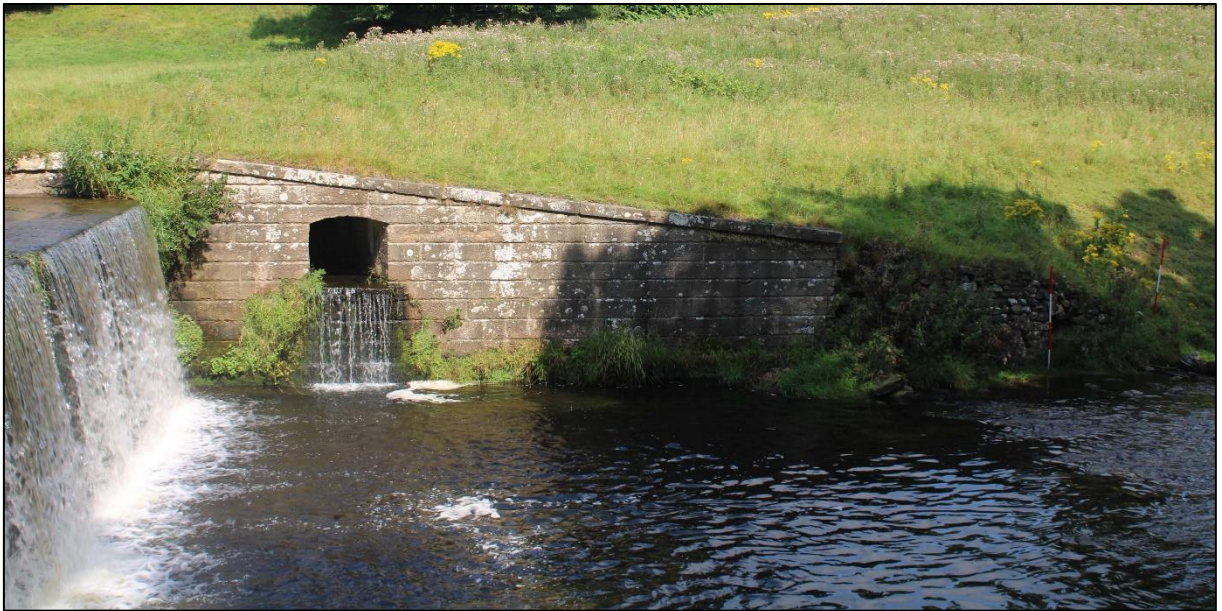
Plate 3. North wall including ashlar section.

The North wall of the outlet comprises two elements. Immediately downstream from the weir cascade this consists of well-dressed regular coursed ashlar blocks, and gently slopes down from west to east under horizontal coping stones (Plate 3). This section is believed to date from the 1890s refurbishment of the outlet and was not to be impacted upon by the proposed repair works. The second element comprises the drystone section immediately to the east (downstream) of the higher ashlar build, which is to be subject of the current repair work (Plate 4). At the time of the initial pre-commencement recording the main elevation of this drystone section was partially obscured by vegetation (Plates 5 and 6). The drystone element consisted of a combination of water worn cobbles / small boulders, together with roughly squared quarried limestone blocks and thick flags. No tool marks were observed on any of the masonry. Whilst no bonding material was evident between the majority of the individual stones the lower courses (approximately 0.50m height above the river water level) included hard grey cement render, presumably as a recent attempt to protect the wall from river erosion (Plate 7).

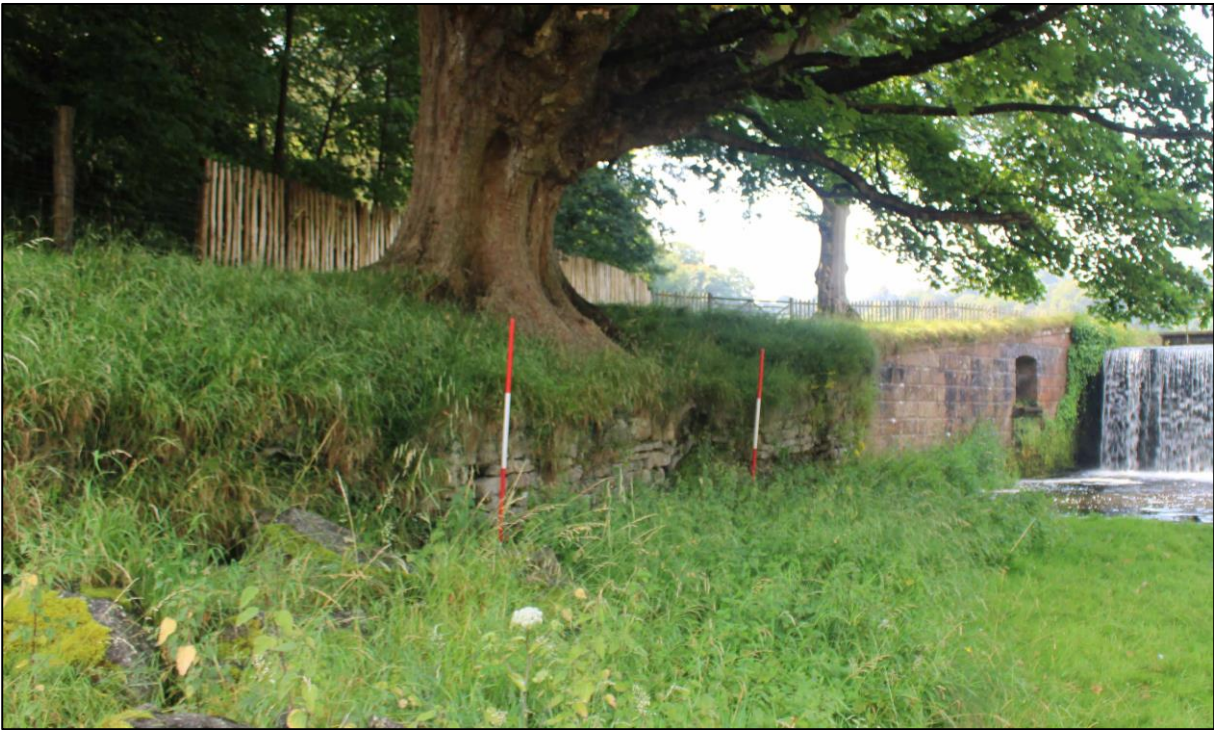
Plate 9. South wall, general oblique view, looking southwest.

Although the project had originally included for repairs to the south wall the works programme was amended so no physical intervention to the south wall is planned for the immediate future. The Level 1 pre-commencement recording was, however, undertaken. As with the north side, this section of the riverbank wall comprises two distinct elements, the well dressed ashlar section closest to the weir cascade, presumed to date to the later 19th century, and the drystone section immediately to the east (downstream) of this (Plate 9). As there had never been any intention to carry out any repairs to the ashlar element, the recording was concentrated on the drystone section (Plates 10 to 12). Some elements of the south wall were again partially obscured by vegetation. Whilst this prevented detailed recording of the entire wall elevation it did not prevent an assessment of the overall construction method from being made. As with the north wall the drystone section of the south wall was constructed with a combination of water rounded cobbles / boulders, and sub-rectangular blocks and flags of limestone. No bonding material was evident. The westernmost section of the drystone

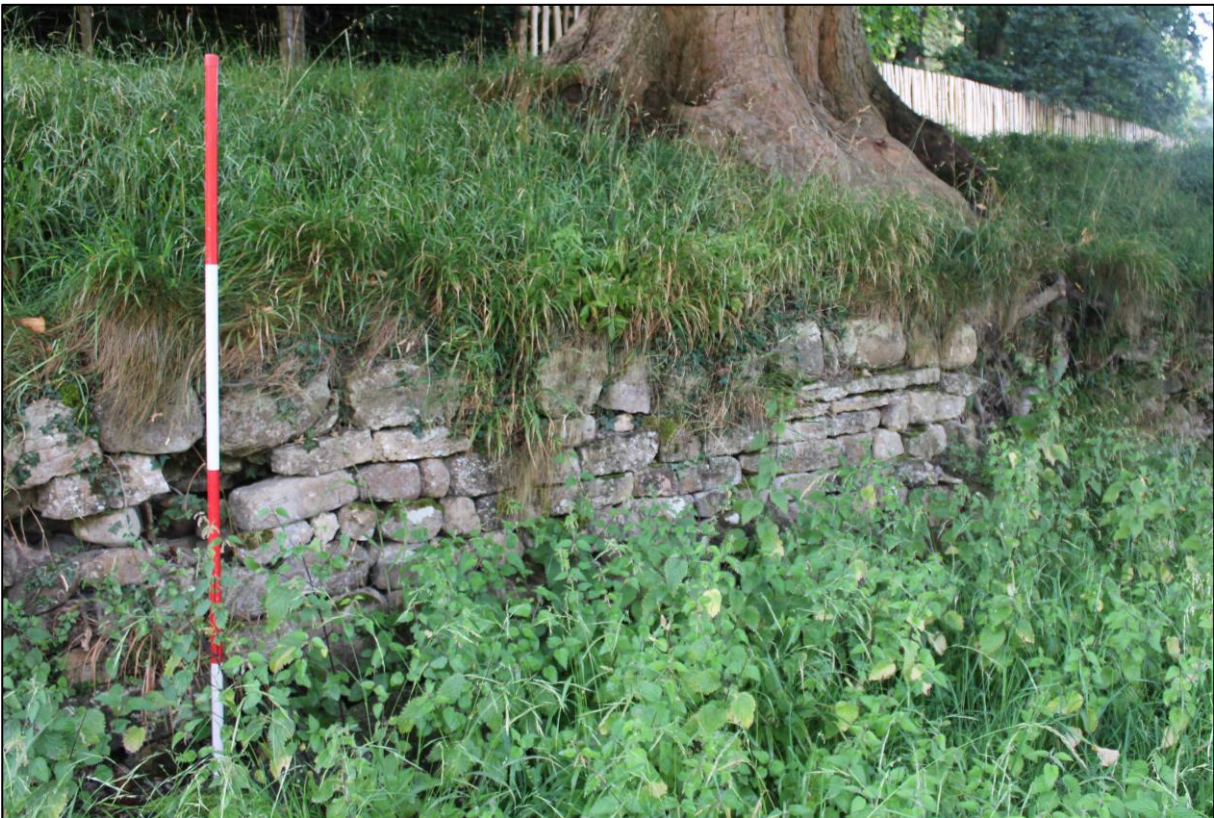
wall was the best preserved, and highest, continuing the gradual slope downstream, from the adjacent ashlar portion (Plate 13). Further to the east the south wall was less well preserved and lower, with individual blocks having been displaced (Plate 14). In places the lower part of the wall had lost substantial portions of the facing stones (Plate 15). The most significant area of damage was located immediately below a substantial (sycamore) tree, where roots had caused the complete loss of a section of the wall, in excess of 1m across (Plate 16).

Plate 14. South wall, east section, looking southwest.

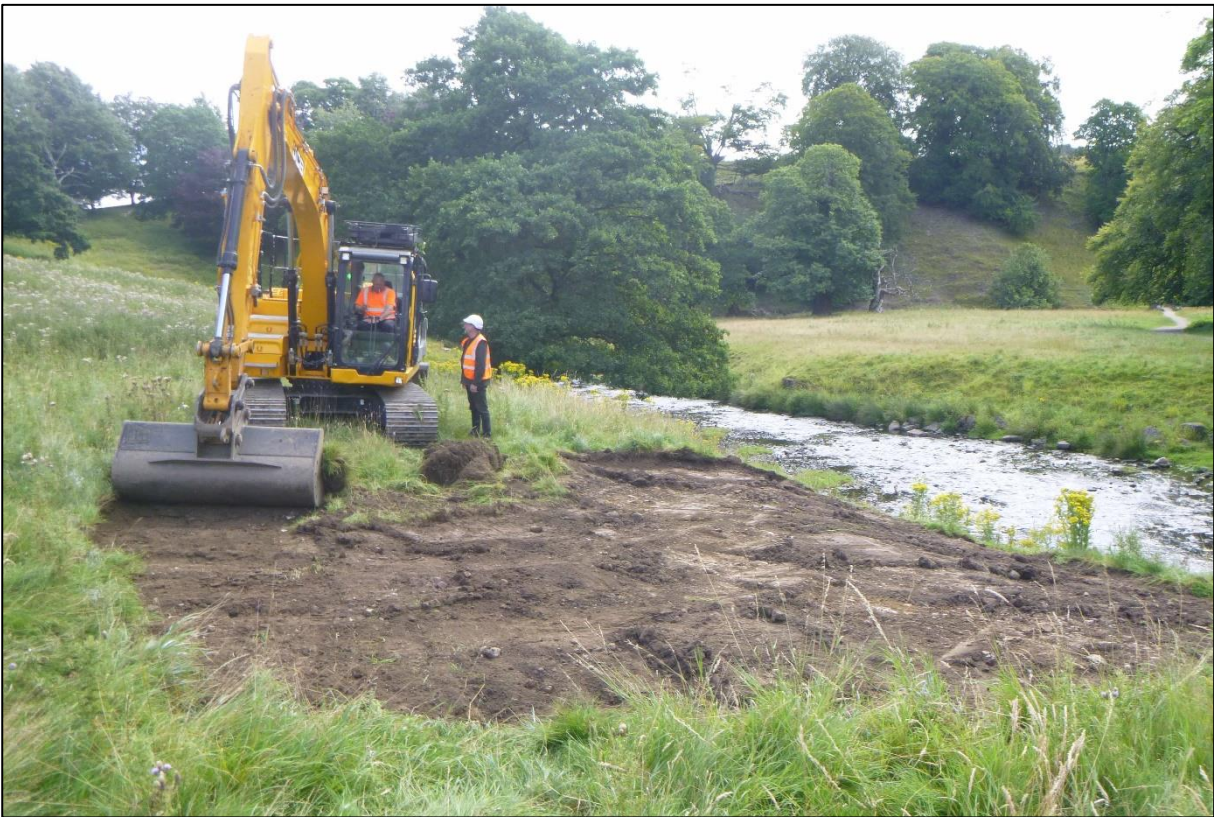
Plate 17. Topsoil strip.

The watching brief initially consisted of monitoring the machine stripping of a works area, approximately 10m x 10m square, immediately to the north of the north bank wall (Plate 17). This involved the partial removal of the modern turf and mid brown clay sand silt topsoil (100). The topsoil was 0.15m thick. Within parts of the stripped area the underlying firm yellow brown sandy clay, with cobbles (101) was observed, which is believed to be a natural glacial deposit. Within the part of the stripped area closest to the river the full depth of the topsoil was not stripped as the ground here was raised to form a level, safe working area.

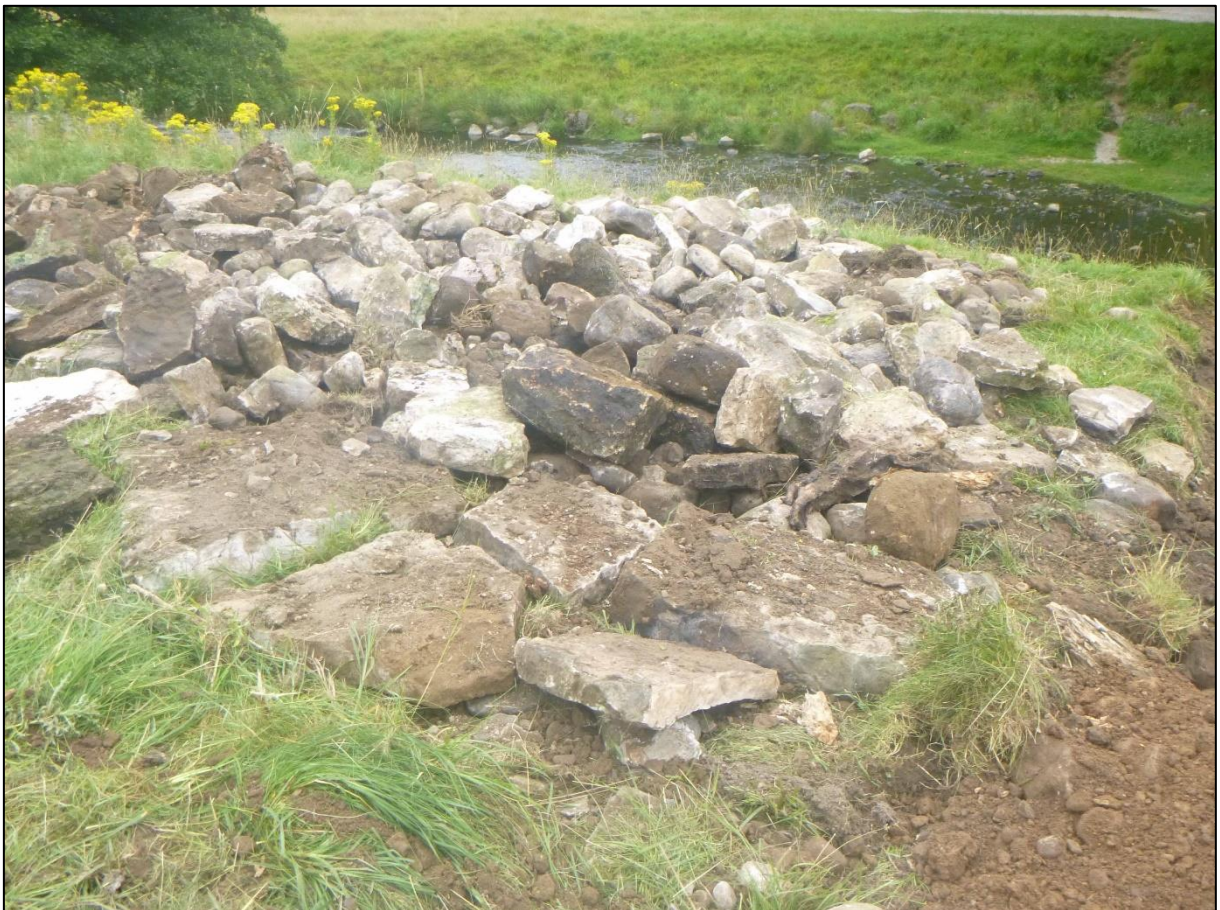
Plate 19. Reclaimed stone.

The level working area was then utilised to provide machine access to assist with the careful dismantling of the wall (Plate 18). The reclaimed stone was carefully placed to allow the attending archaeologist to inspect it for any reused masonry or tool marks (Plate 19). None of the stonework included any toolmarks and none of the fragments included any features that suggested reuse from elsewhere on the estate. This was notable in its contrast with elements of the canal walls located closer to the Abbey ruins where numerous fragments of medieval masonry were present (see for example JB Archaeology Ltd, 2016 and Newman, 2017).

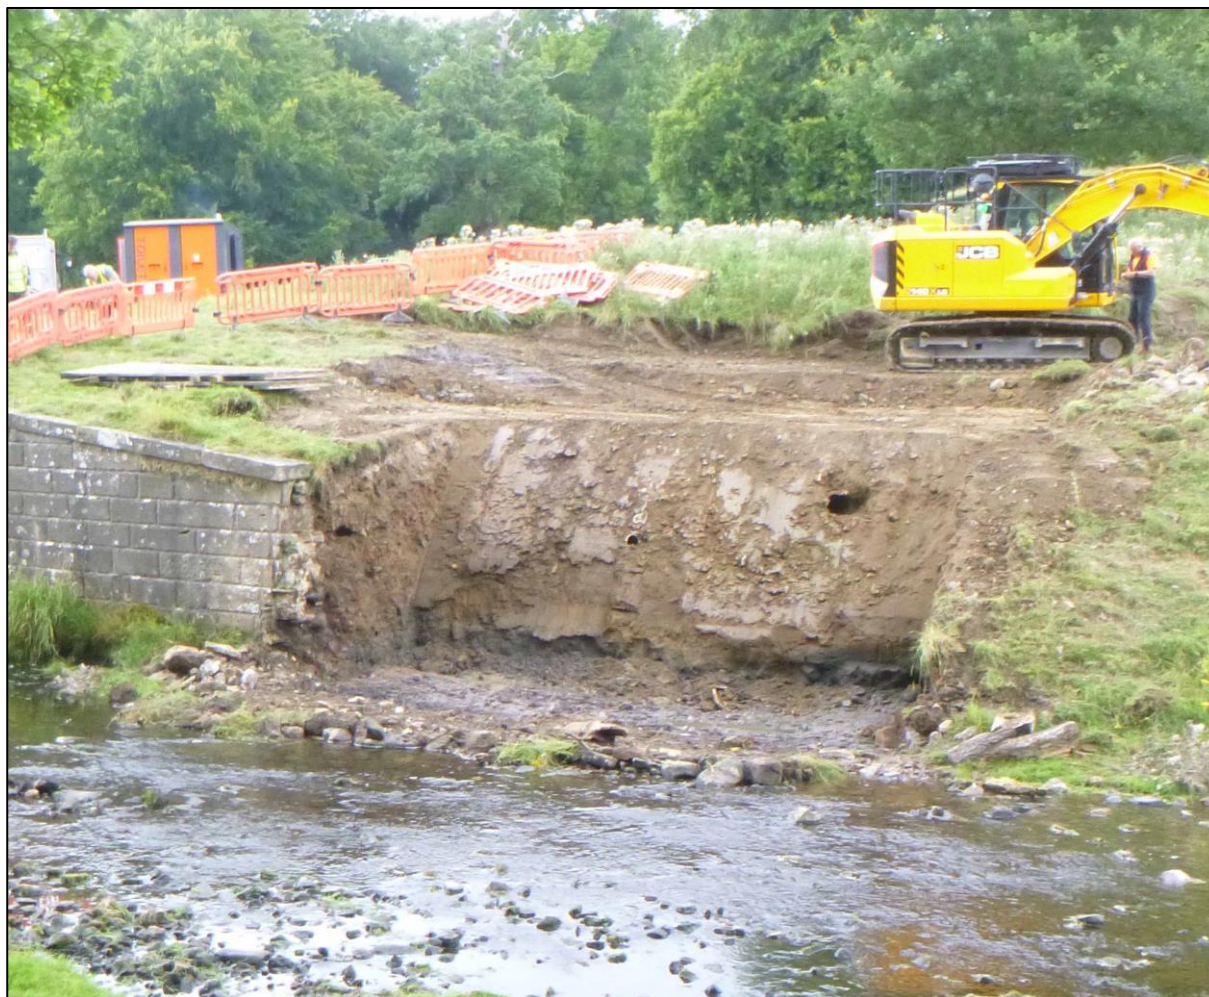
Plate 20. General view of excavation area.

Following the removal of the drystone wall, the bank behind was mechanically excavated to provide sufficient space for the insertion of the new gabion baskets and to rebuild the external face of the wall. At its base this excavation extended to a maximum of 2m back from the original wall face, with the northern limit of excavation being sloped for safety reasons so at the top of the bank the excavation was around 3m back from the original face of the wall (Plate 20). The exposed vertical sections were rapidly cleaned and recorded to enable an understanding of the archaeological sequence impacted upon by the excavation (Plates 21 and 22 and Figure 5).
